Client: Emily Neumaier
Project Location: 28 Laurel Avenue, San Anselmo
Inspection Date: July 31, 2019
Arborist: Ben Anderson

Assignment

Emily Neumaier contacted Urban Forestry Associates to request an inspection and arborist report regarding the mature Southern Magnolia (*Magnolia grandiflora*). The tree was reportedly causing damage to the adjacent home. This report is to be used as part of an application for a Tree Removal Permit from the Town of San Anselmo.

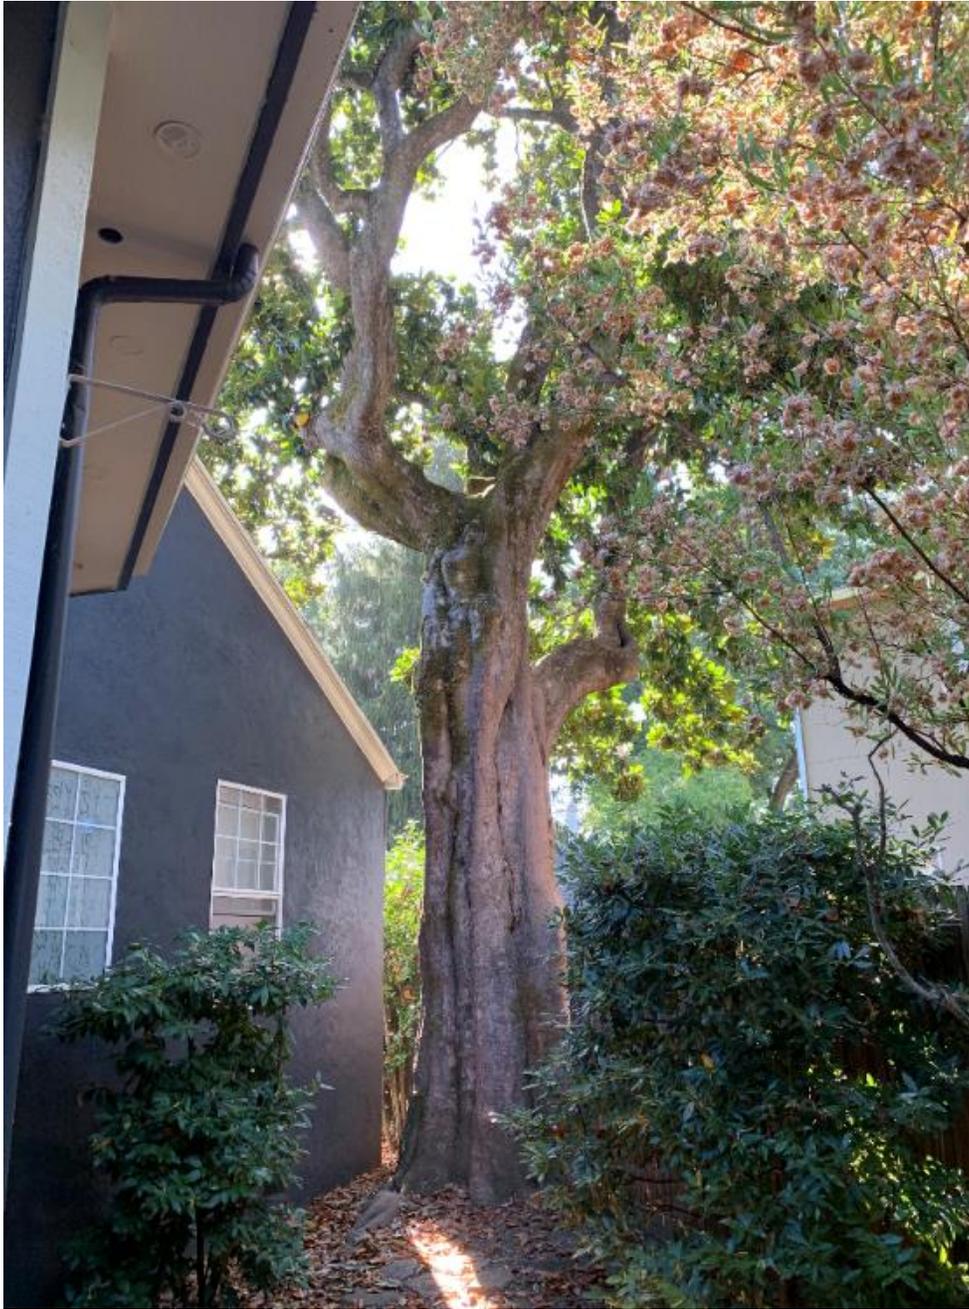
Figure 2. Subject tree as viewed from the west.

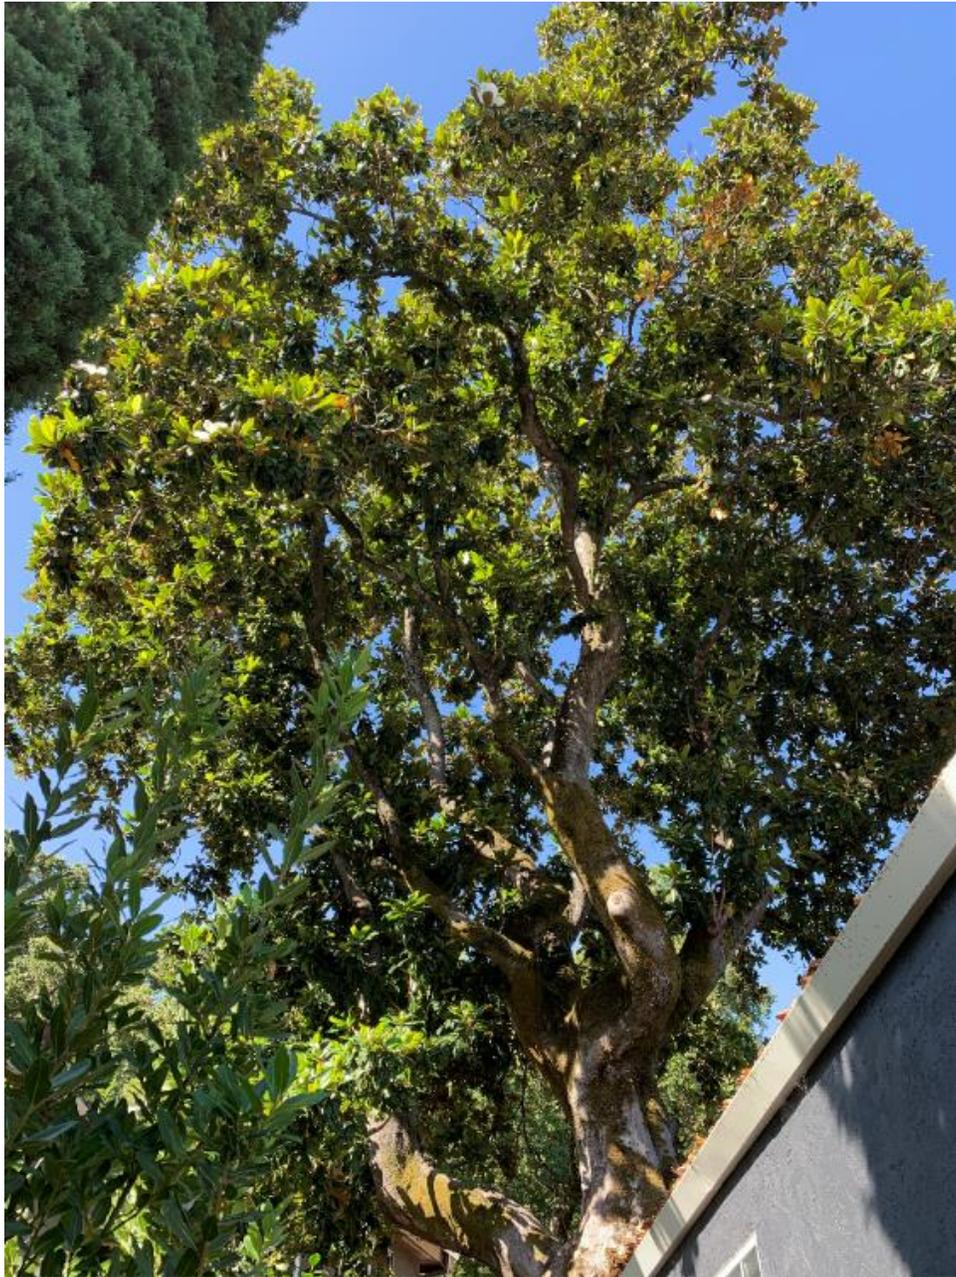
Figure 3. Canopy of subject tree as viewed from the north. Home at 28 Laurel visible in lower right.

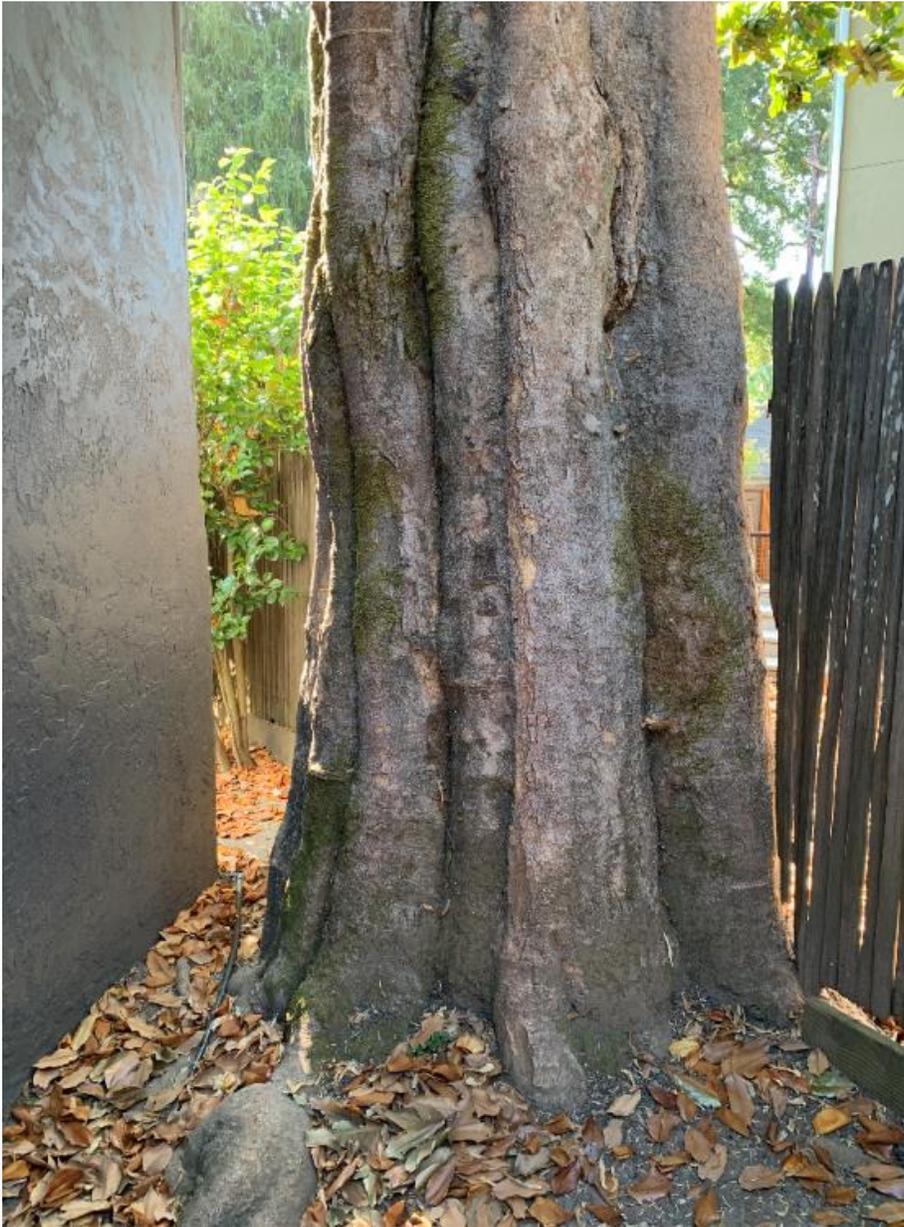
Species	Southern magnolia
Diameter	Approximately four feet. The property fence prevented actual measurement.
Location	See map in Figure 1. The base of the tree is within one foot of the foundation near the south corner of the home (Figure 4). It sits on the apparent property line between the subject property and the adjacent property to the south (2 Hillcrest Avenue).
Health	Good. Full, healthy canopy (Figure 3). See explanation of condition ratings in Table 1.
Structure ¹	Good.
Form ²	Good.
Damage	There is reportedly some movement of the doors, windows, and floors in the home, though no cracks in the drywall were observed. Several doors are out of plum and will swing open/shut on their own. It is possible the drywall was replaced in recent years. I opened the access hatch to the crawlspace below the home, located on the north corner of the home. Below the home is clean and open. There are several vents that allowed enough light for me to see a large crack in the stem wall adjacent to the tree. It was too dark to obtain a quality photograph and the crack is covered by stucco on the exterior of the home.

Figure 4. Close up of base. Home to left. Property fence to right.

This tree has outgrown its available space and is at a high likelihood of doing further damage to the home's foundation. It is too close to the home for root pruning and root barriers to be a reasonable option. The only way to effectively mitigate the root damage is through immediate whole-tree removal.
