July 10, 2019

100 West Hillside Ave, San Anselmo, CA.

Observations and Discussions:

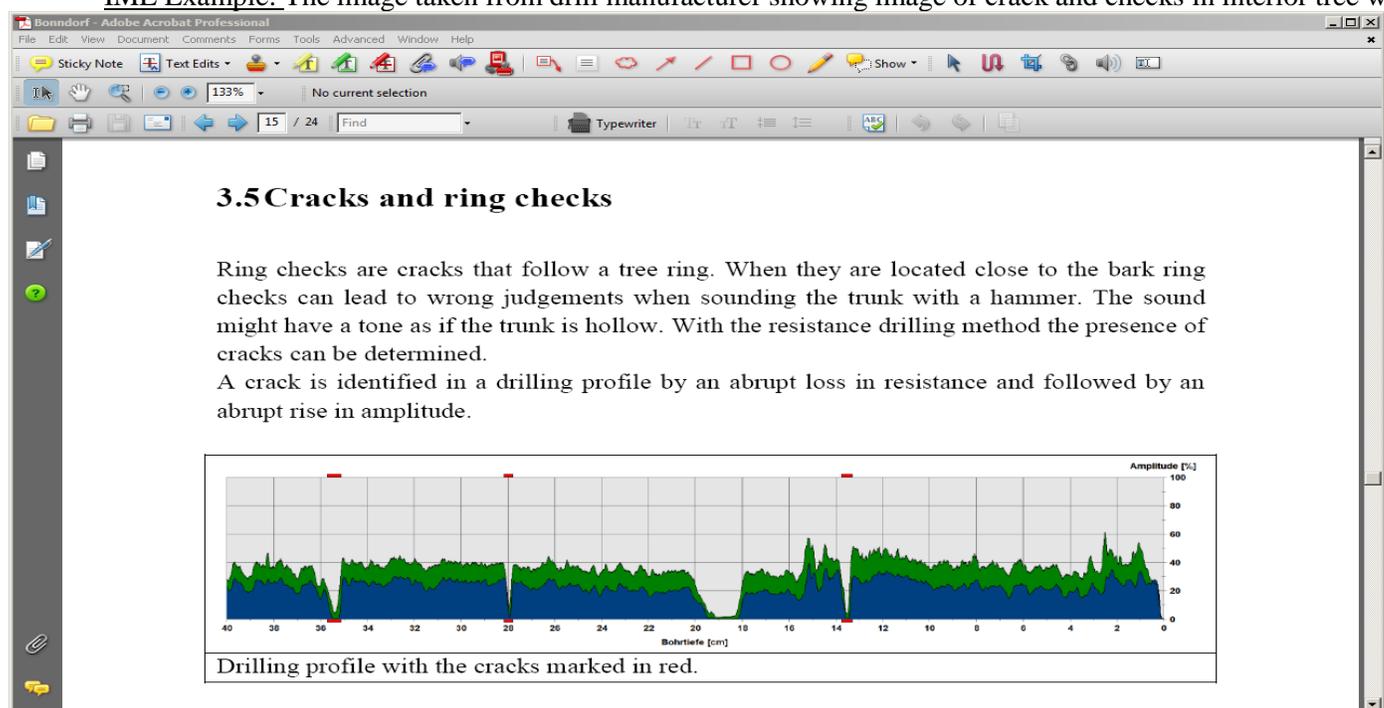
In the opinion of this review, cracks are measured with specialty tools including resistance drills that measure wood integrity and results are displayed on graphs that are projected as amplitude readings on the graph. Therefore, a crack would register as a drop in amplitude (loss of resistance) and as the drill needle encounters solid wood (resistance), the amplitude would spike on the recording graph.

IML Example: The image taken from drill manufacturer showing image of crack and checks in interior tree wood.

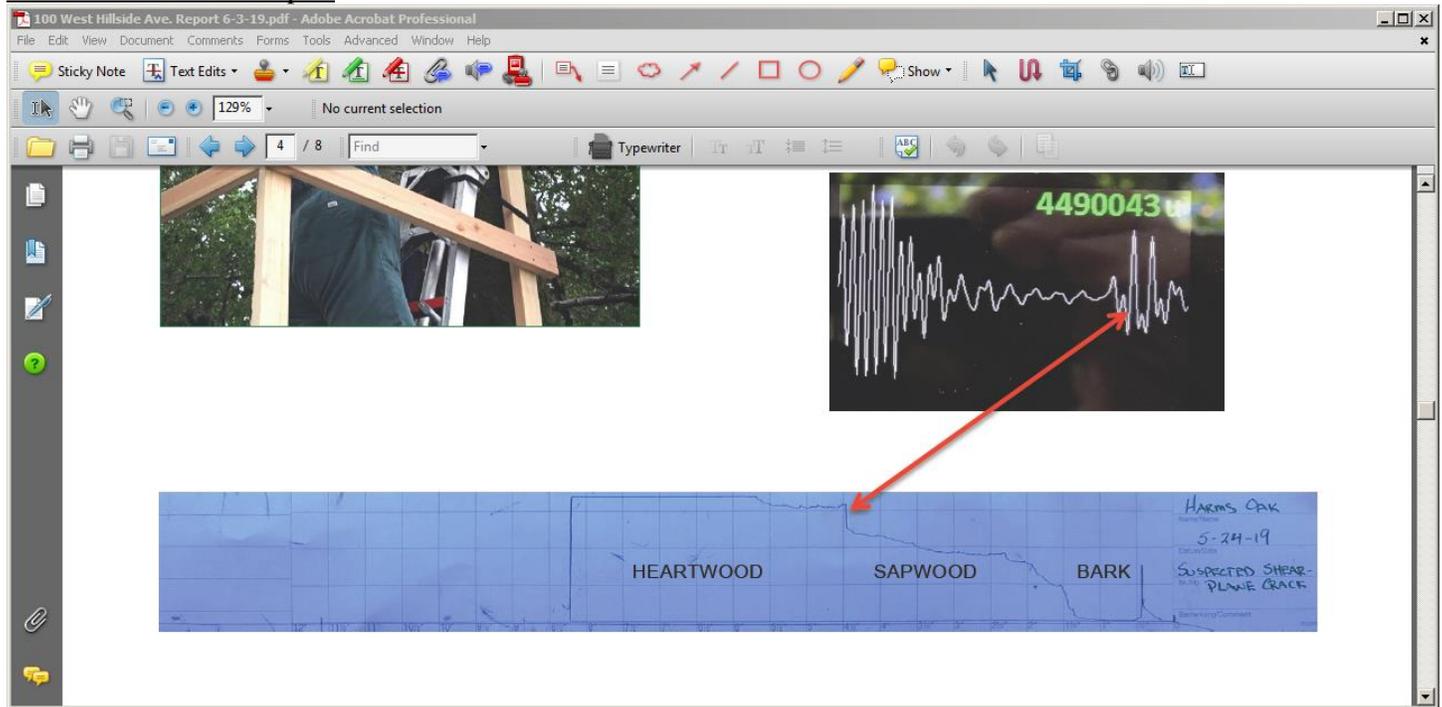
Profile from the Julin report

In the resistance drill measurement for this Oak tree there is an increase in amplitude recorded by the drill reading when it transitions from sap to heartwood but there is not the abrupt drop in drill profile indicating a separation or void created by a crack. There is not a clear explanation why this reading drop is missing in the drill reading profile as it transitions from sap to heartwood.

There may be other unknown reasons for the discrepancies in these two readings measuring interior wood cracks. The former drill profile, the IML reading on page one of this report is established by the drill manufacturer and taken from the manual. The manual suggests that drill speed setting, angle of drill path, and a dull needle drill tip would alter a reading. A communicate with the manufacturer suggests that additional drill testing and documentation could provide a more accurate understanding and resolve questions of the test process.

The Coast Live Oak tree was inspected during a site visit and the outer limb separation that resembled a longitude separation did not progress into the limb of the tree from the outer surface. This is not a definitive conclusion that an internal radial crack may not be present. However, the resistance drill measurement does not record a drop in resistance along the drill path. It does show a transition when the drill needle passes from sap to heartwood. In conclusion, this review would require additional testing and details of additional test that could answer present questions before a decision can be made. The manufacturer manual describes that if a clear interpretation of the drill reading can be made the additional testing is necessary.
