**Client:** Serena & Chris Clark  
**Project Location:** 129 Laurel Avenue, San Anselmo  
**Inspection Date:** October 17, 2019  
**Arborist:** Ben Anderson

## URBAN FORESTRY ASSOCIATES, INC.

### Assignment

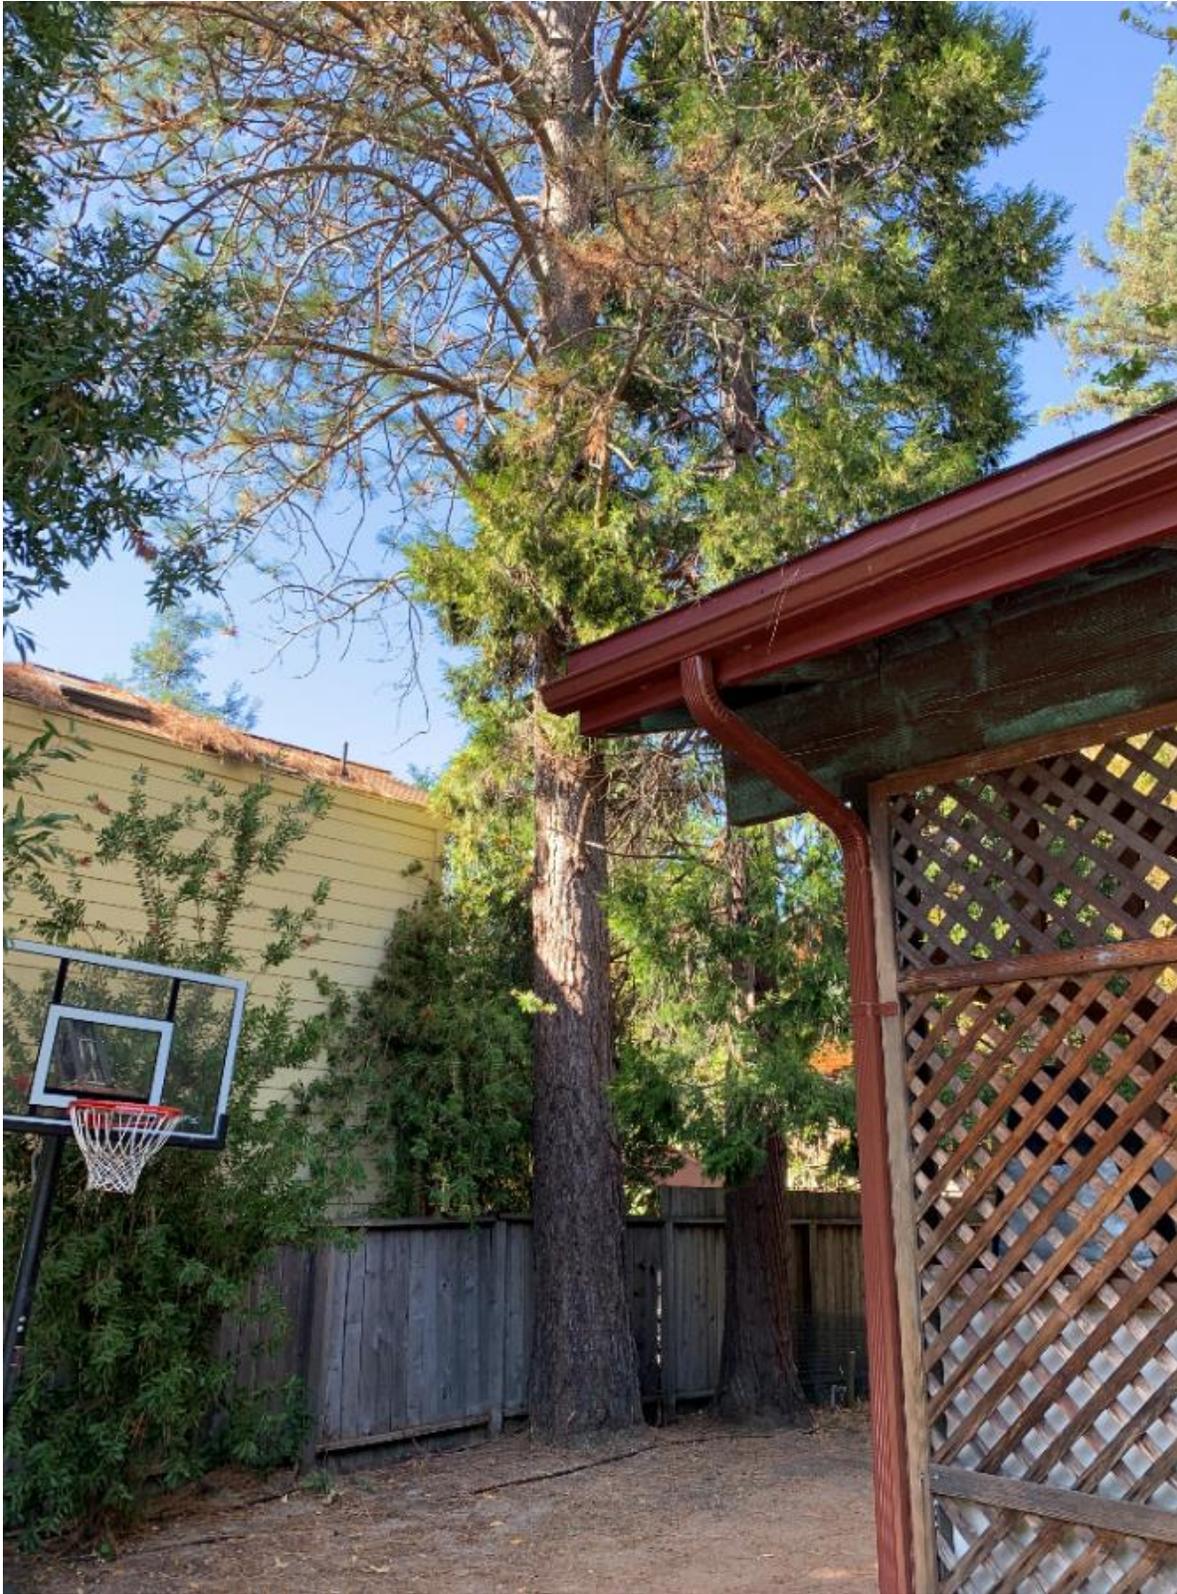
Species	Canary Island pine ( <i>Pinus canariensis</i> )
Diameter	31.3 inches
Location	Within one foot of and possibly touching the west property boundary between 129 and 119 Laurel Avenue. The canopy of the tree extends over the home at 129 and the studio above the garage at 119 (Figure 1). The base of the tree is within five feet of the garage foundation at 119. The tree is growing within four feet of a mature incense cedar ( <i>Calocedrus decurrens</i> ) (Figure 2).
Health	Good. See explanation of condition ratings in Table 1. There are many mature trees on the subject property and in the neighborhood generally.
Structure <sup>1</sup>	Good.
Form <sup>2</sup>	Good though it is affected somewhat by the shared canopy space with the incense cedar.
Miscellaneous	The pine needle debris is prolific on both properties. A large amount of needles were accumulated on the roof of the studio at 119 (Figure 2).

The pine is located inside the defensible space zone of the subject home and the neighboring home at 119. Both homes are in the Wildland Urban Interface (WUI). FIRESafe Marin recommends removing pine trees from inside the defensible space of a structure “due to their fire prone nature”. The leaf litter on the roof of the studio would be very difficult to access to clear as there is no deck and it is on the second story.

**Figure 2. The subject pine is the center tree in the image. Cedar is to the right. Needle accumulation visible on the roof to the left of the subject tree.**

Incense cedar is native to California while Canary Island pine is not. The two trees are planted far too close together for such large species. The cedar is in a preferable location as it is further from foundations, is a native species, and is less fire prone. It is a reasonable management decision to remove the pine to mitigate fire risk to both properties and to favor the health and structure of the cedar. The removal of this tree will not have a significant impact on the overall canopy cover of the neighborhood as the cedar should fill the space nicely.
