Client: Noah & Dinah Stroe
Project Location: 52-54 Tamalpais Avenue, San Anselmo
Inspection Date: August 8, 2019
Arborist: Ben Anderson

URBAN FORESTRY ASSOCIATES, INC.

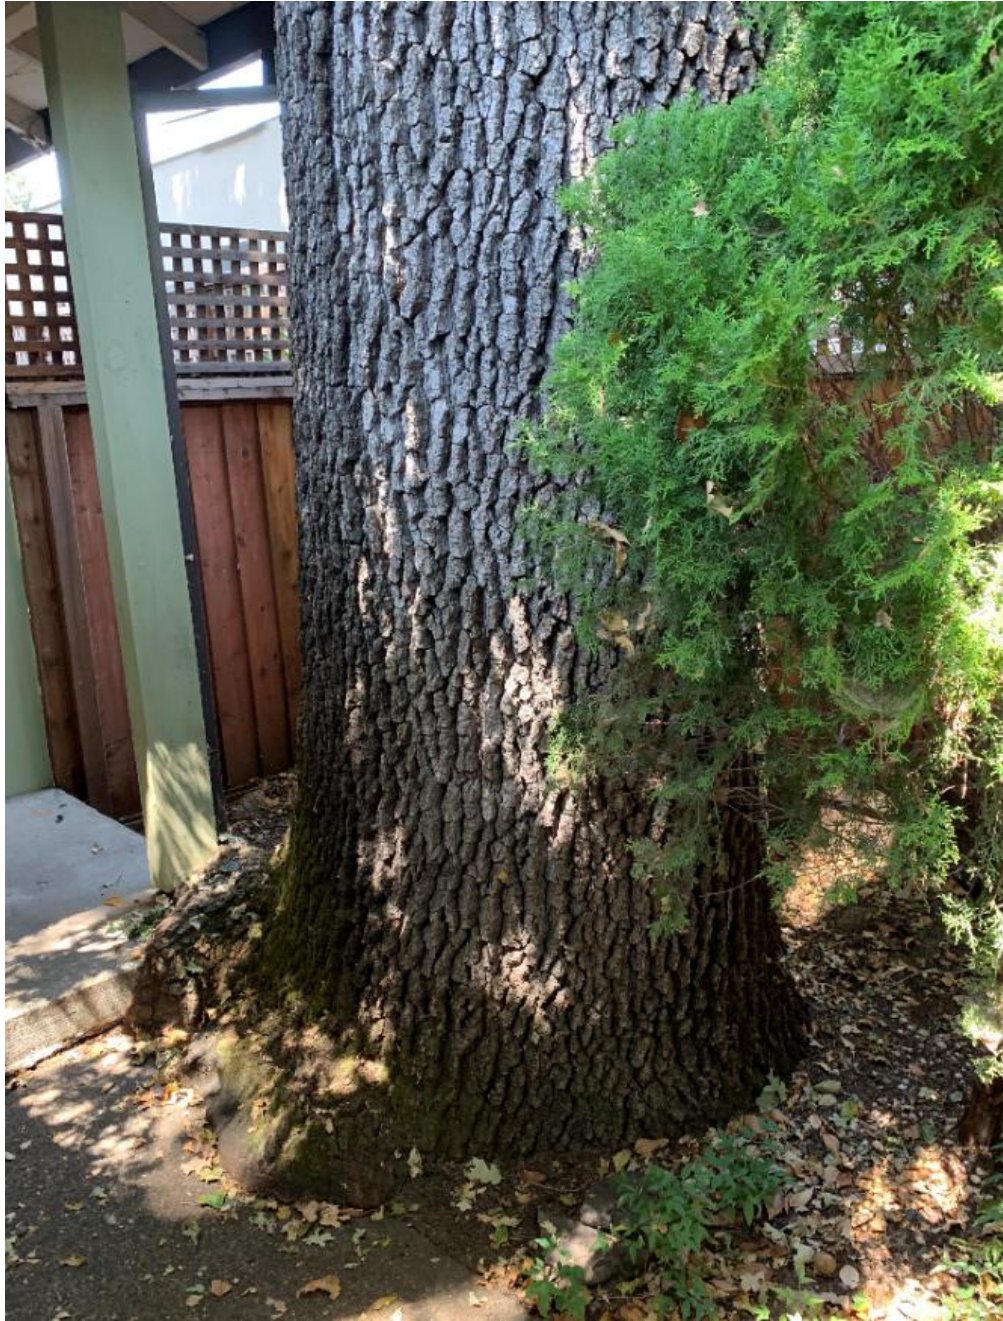
Species Valley oak
Diameter 39.3 inches
Location East of the home (see map in Figure 1). The south-most of the two subject trees. The tree base is engulfing the front walk and stoop (Figure 2) and the trunk is nearly in contact with the eave.
Health Good. See explanation of condition ratings in Table 1.
Structure¹ Poor. The canopy has a strong asymmetry over the home (Figure 4). This appears to be the result of a large valley oak previously on the property to the east that reportedly failed several years ago but is still visible on Google Earth imagery. The branches of the tree are over-extended and target the home and driveway.
Form² Fair. Again, strongly asymmetrical balanced to the west over the home.

The impact of the engulfed sidewalk on tree stability is unknown but this is certainly a structural defect as it disrupts structural, tension side of the load bearing column of the tree and could interfere with lateral root development.

Figure 2. Base of Tree 1 engulfing the sidewalk and stoop.

These trees are at an elevated likelihood of large limb failure onto the home, which would have severe consequences. They are nearing the end of their safe utility period and removal is a reasonable option. Unless the tree owner is willing to spend significant amounts and to live with an elevated risk even after the pruning, I recommend whole-tree removal of both trees.

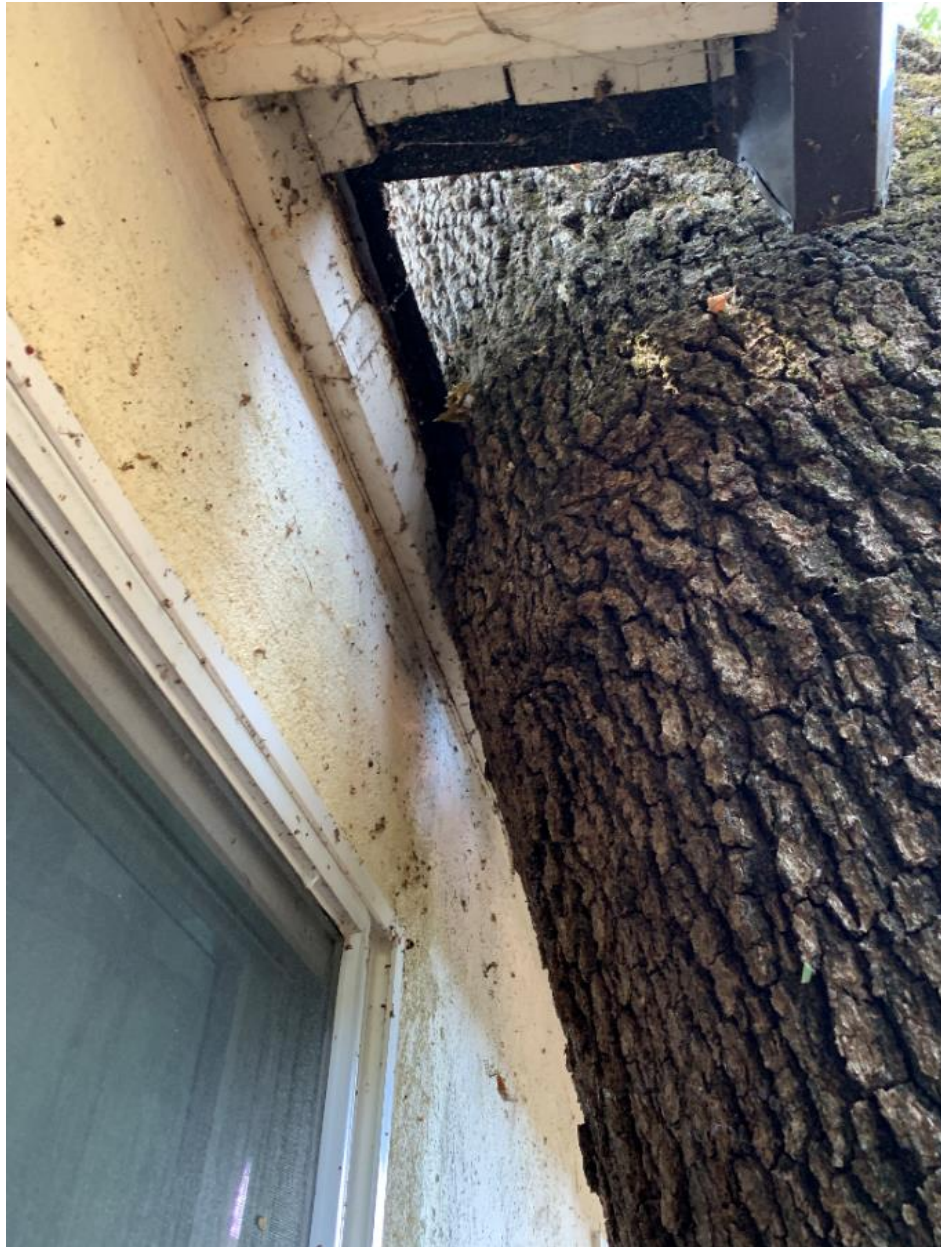
Species Valley oak
Diameter 38.7 inches
Location On the east side of the home, behind the property fence. North of Tree 1. The trunk is in contact with the main home (Figure 3). The eave was already modified to the greatest extent possible without changing the framing of the wall.
Health Good.
Structure Poor. Nearly identical to Tree 1 (Figure 5). One of the large limbs over the home appears to be flattened out, possibly indicating an internal fracture.
Form Fair. Nearly identical to Tree 1.

Tree 2 will only continue to increase in diameter, further damaging the home and the trunk of the tree. Unless the home is seriously modified, the tree will have to be remove in the coming years.

Figure 3. Trunk of Tree 2 in contact with home. Past modifications to the eave visible.

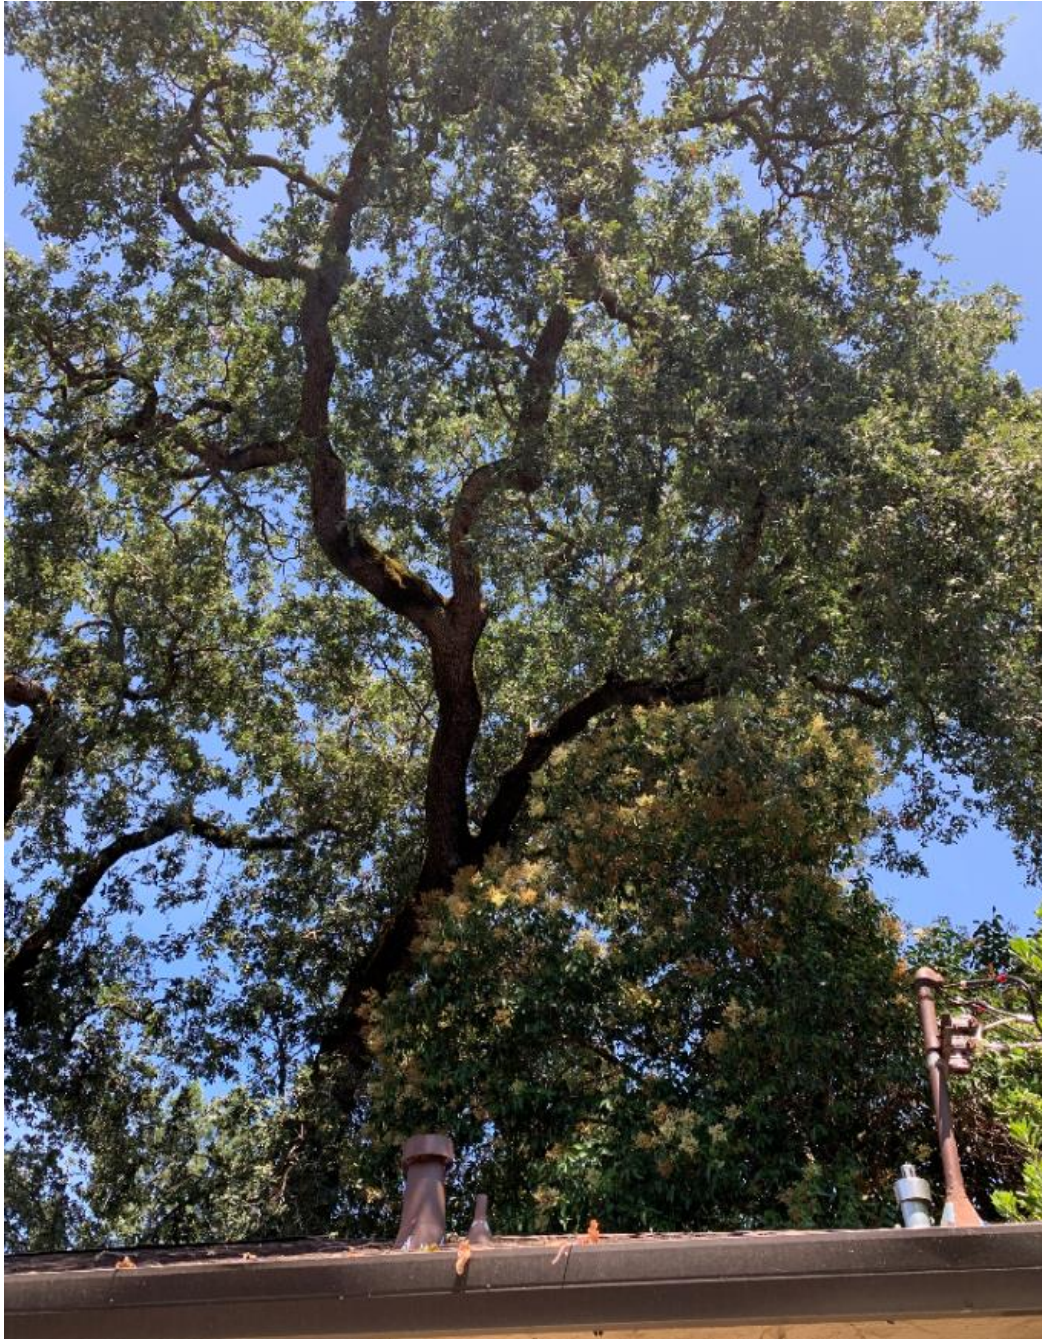
Figure 4. Canopy of Tree 1 growing over home as viewed from the driveway.

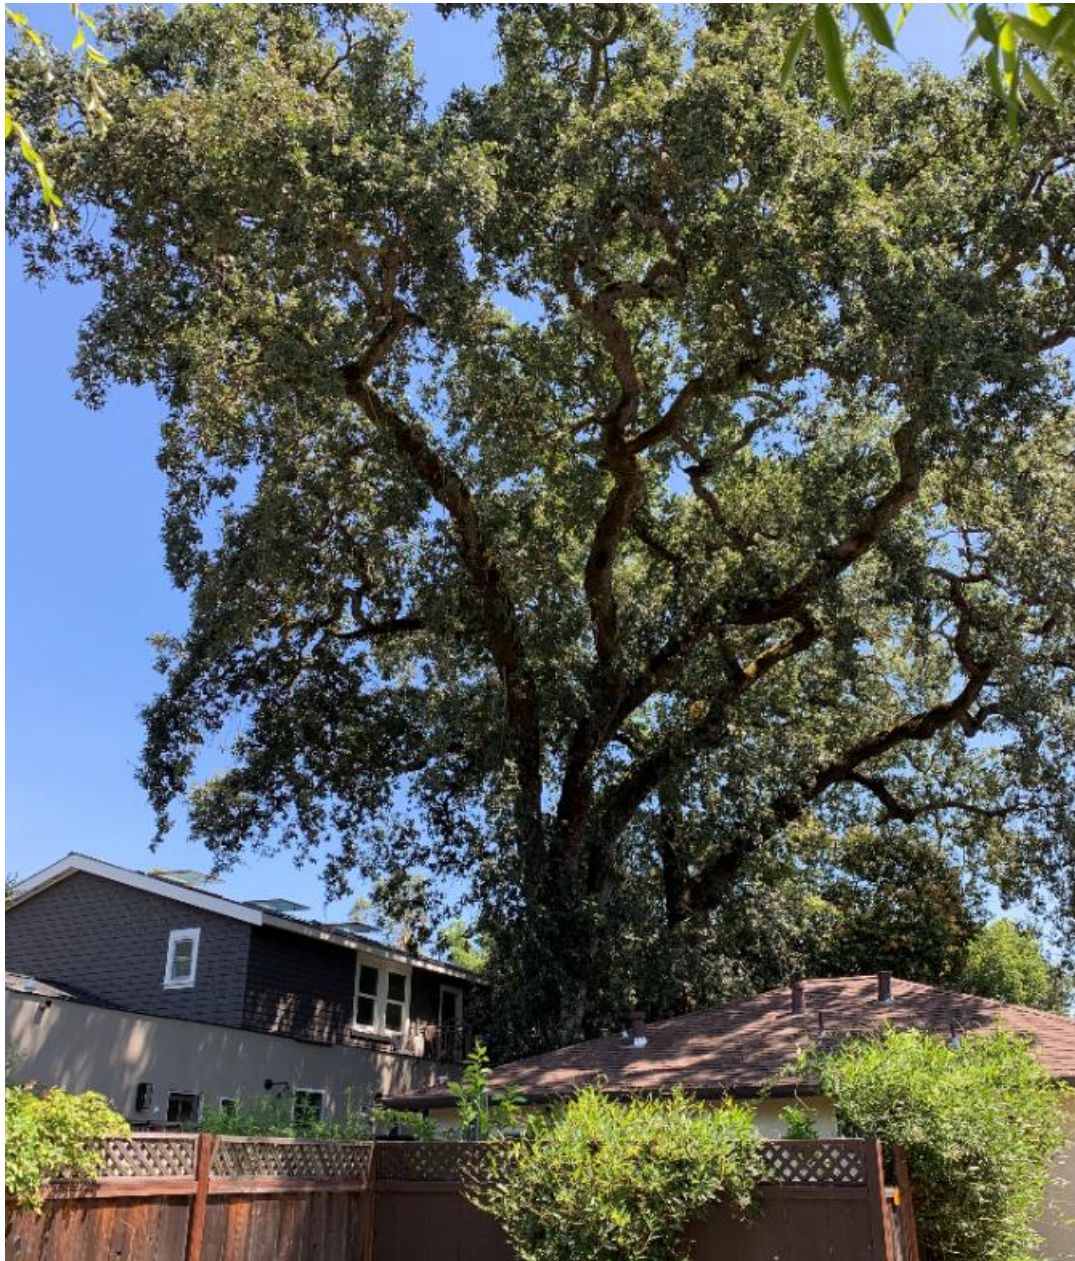
Figure 5. Canopy of Tree 2 growing over home. Note long, over-extended limbs with few bifurcations.
