## ARBORIST REPORT

### Pre-Sale Inspection of Two Valley Oaks 52-54 Tamalpais Avenue San Anselmo, California (APN: 007-211-30)

August 15, 2019

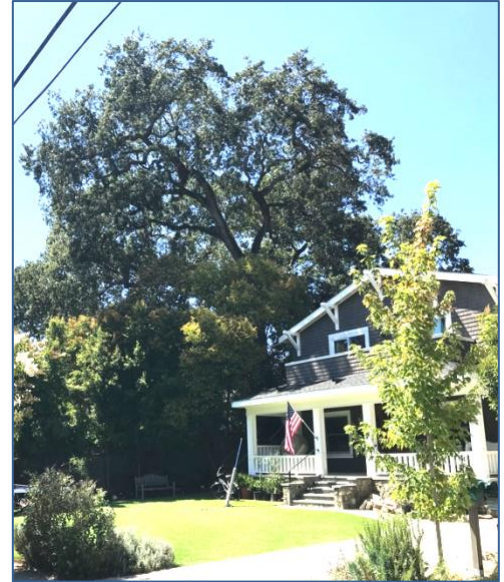
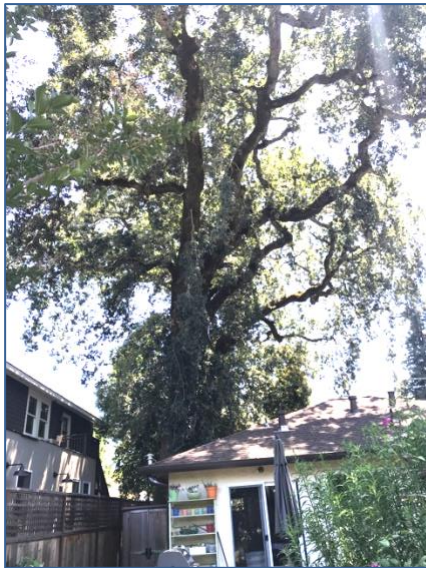
Tree 1 is a mature heritage valley oak that grows at the front door step of the 54 Tamalpais Avenue unit. It measures 42" in diameter at breast height (dbh), divides into two scaffold limbs at 25' above grade that are strongly attached and support a fairly well balanced crown of dense foliage. I found no evidence of rooting instability or lower trunk decay. The root collar has pillowed over the concrete walkway and step, which limits normal development of the lower trunk. At this stage this pillowing does not seriously affect the stability of the tree. Tree 1 presents a moderate failure risk: the likelihood of large limb failure is "possible", the likelihood of impacting the house and front garden is "high", and the consequences would be "severe".

Both of the subject valley oaks are mature, healthy trees that are large enough to be considered heritage trees by the Town. Tree 2 is causing serious structural damage to the house and I recommend that it be removed as soon as possible to arrest this damage and to allow sustainable repairs to be made. Tree 1 is crowding the walkway where it creates a slight tripping hazard now and may crack the walkway in the future. I recommend that Tree 1 be balanced pruned to reduce the weight over the home and reduced in height using drop-crotch-pruning to lessen its wind sail.

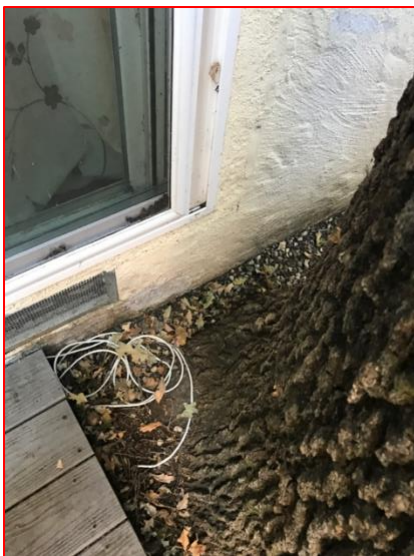
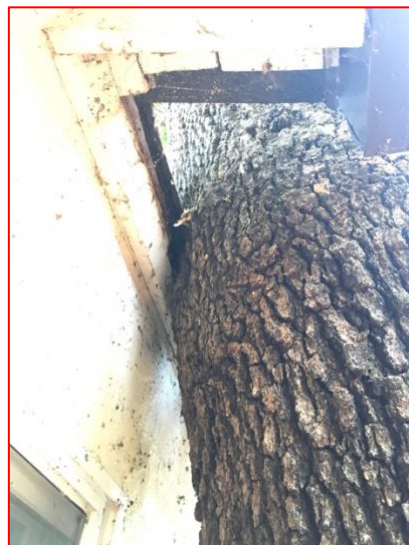
Tree 2 is a mature heritage valley oak that grows along the east side of the 54 Tamalpais Avenue unit. It has a well-tapered lower trunk that measures 38" in diameter at breast height, contacts the home that has been notched (photo below right), and separates into three scaffold limbs at about 20' above grade. These scaffold limbs are strongly attached and support a crown that is more heavily weighted to the west and over the house. Tree 2 presents a moderate failure risk: the likelihood of large limb failure is "possible", the likelihood of impacting the house and front garden is "high", and the consequences would be "severe". Structural roots from Tree 2 have cracked and uplifted the house—cracks are visible on the repaired exterior stucco, interior walls and ceiling, and the floor noticeably inclines near the tree.
