Client: Steve Nielson

Project Address: 50 Ross Avenue, San Anselmo

Inspection Date: October 21, 2019

Assignment

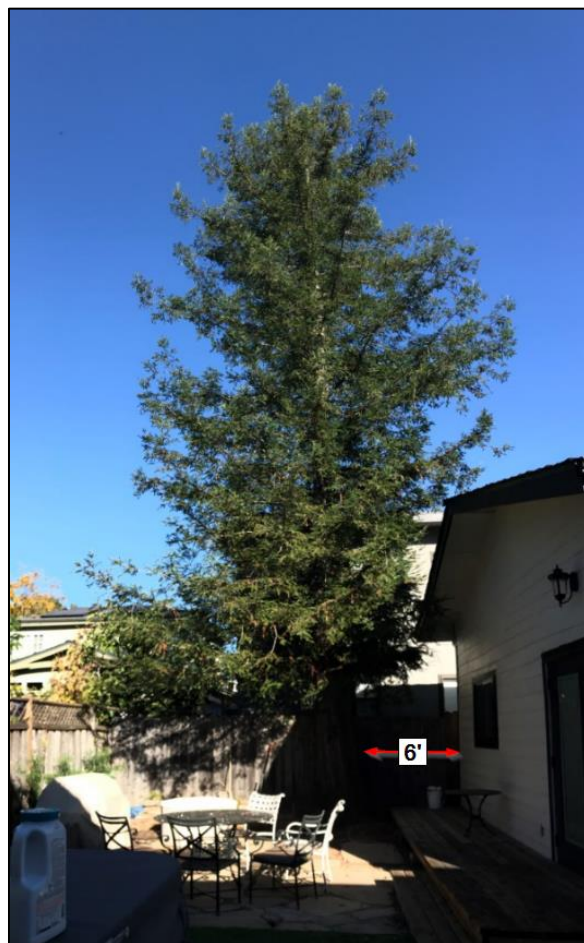
Figure 1. Subject tree as viewed from the Nielson backyard. Note the main trunk stands 6 feet from the foundation of the guest house (right).

Unfortunately, the subject tree is located close to the Nielson guest house and 53 Woodland apartment complex, significantly elevating the likelihood of conflict with the trunk or roots as the tree continues to grow. While coast redwood is not particularly fire prone the lower branches proximity of both nearby structures is out of compliance with fire code and over half the canopy would have to be removed to achieve enough clearance.

The subject tree is very poorly placed and has outgrown the available space. The tree has not even come close to reaching its full grow potential so there is high risk of root or trunk related damaged if the tree is retained. In my professional opinion the only reasonable action to abate the risk is removal of the tree and stump.

Whole tree removal.

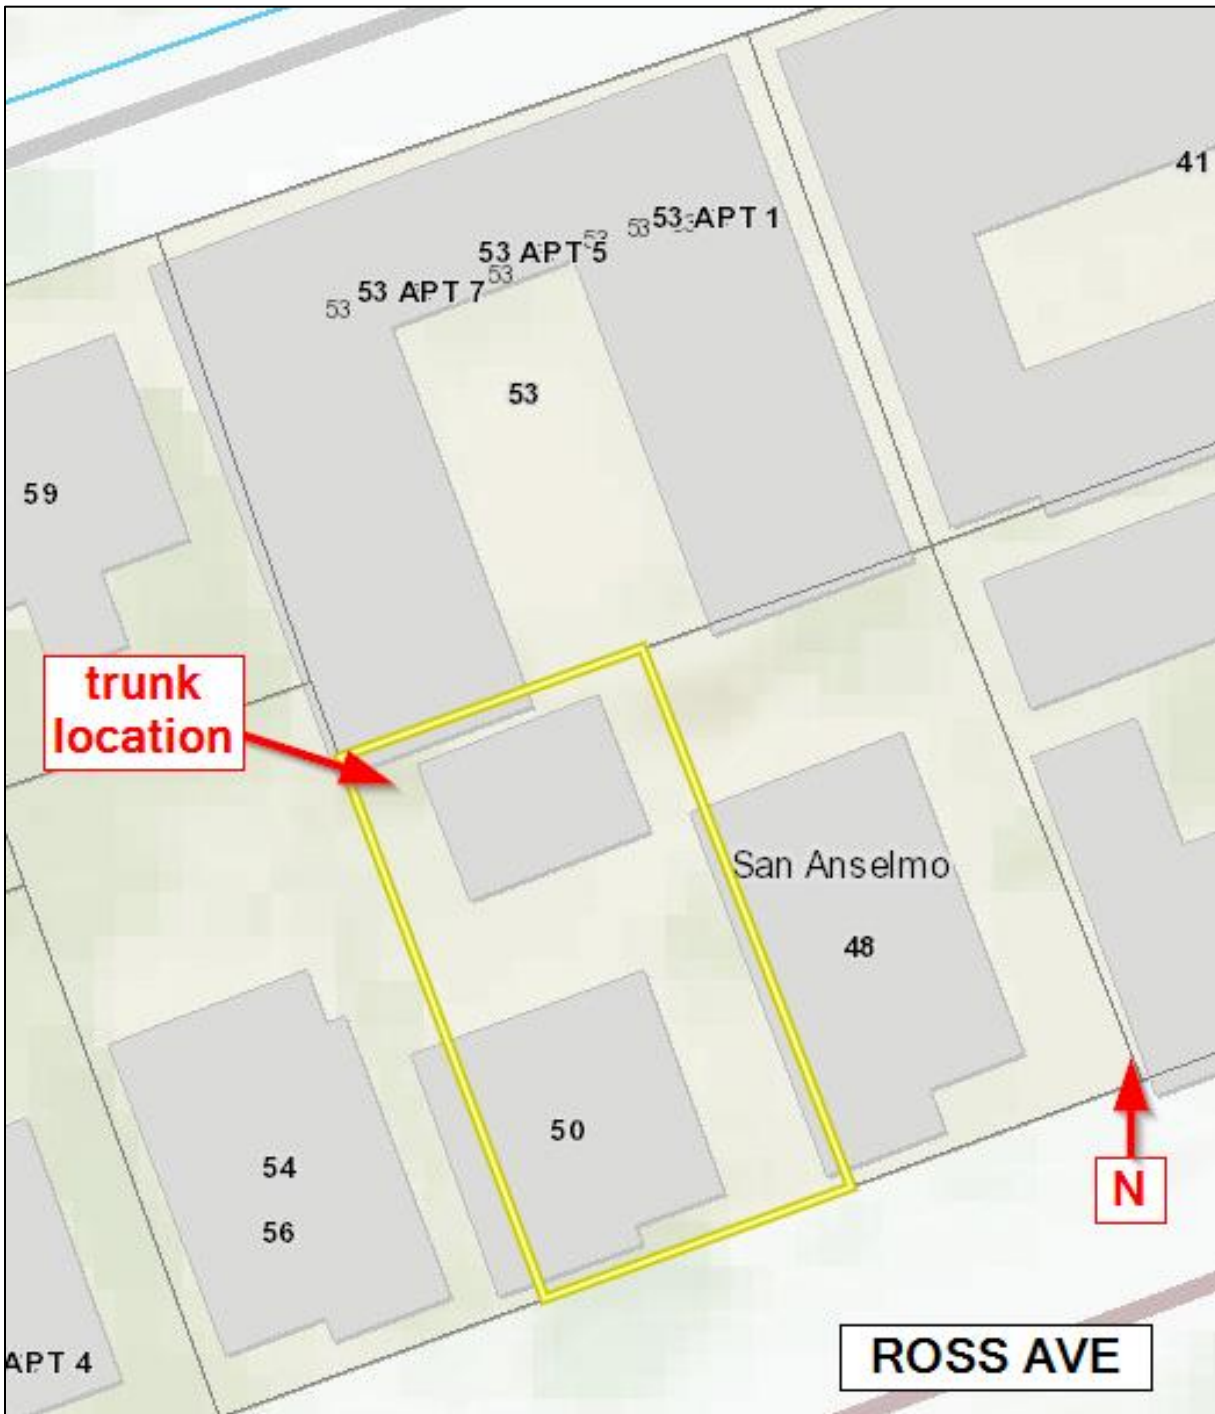
Figure 2. Tree location map.

Location In the backyard growing directly against the common fence between 50 Ross Avenue and the west "wing" of 53 Woodland Avenue. The concrete walkway at 53 Woodland is buckled and the foundation for that structure stands approximately 6 feet from the trunk (See Figure 3). The Nielson guest house is only 6 feet from the tree's trunk (See Figure 2).

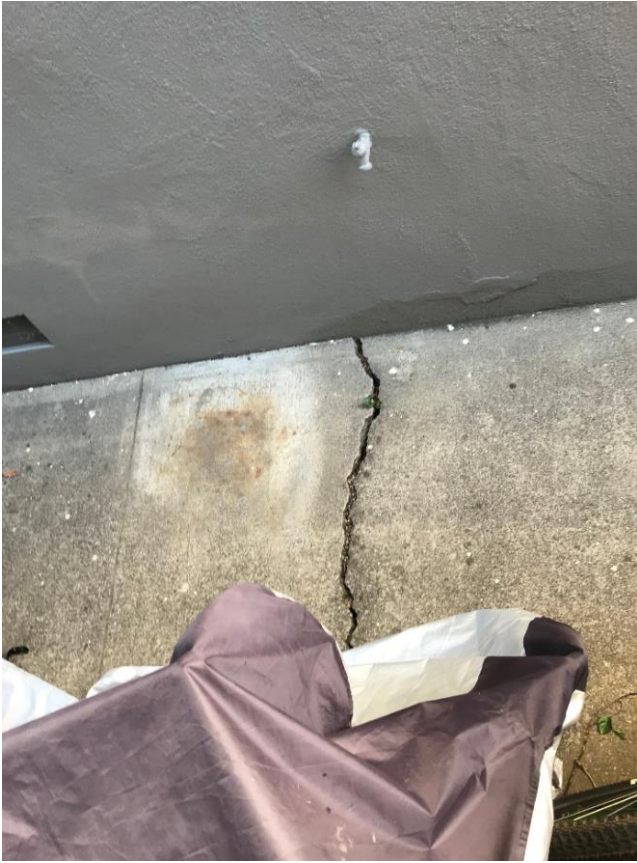
Figure 3. Buckled walkway at 53 Woodland. As viewed from the Nielson property over the fence.

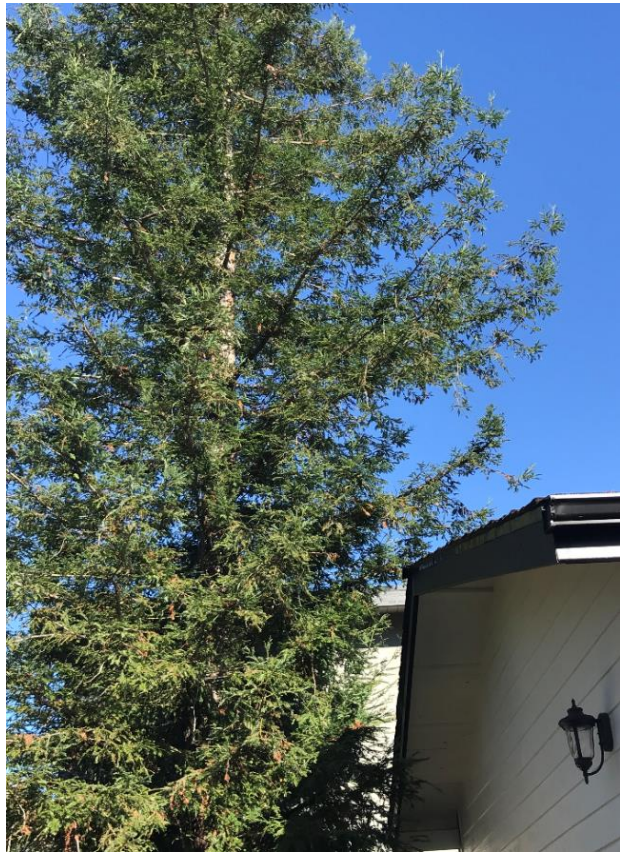
The canopy of the subject tree is encroaching on the roofs of both said properties (See Figure 4).

Figure 4. Proximity of canopy to to Nielson guest house.
