**Client:** Fosec Tree Service  
**Project Location:** 15 Cottage Avenue, San Anselmo  
**Inspection Date:** July 31, 2019  
**Arborist:** Ben Anderson

**URBAN FORESTRY ASSOCIATES, INC.**

## Assignment

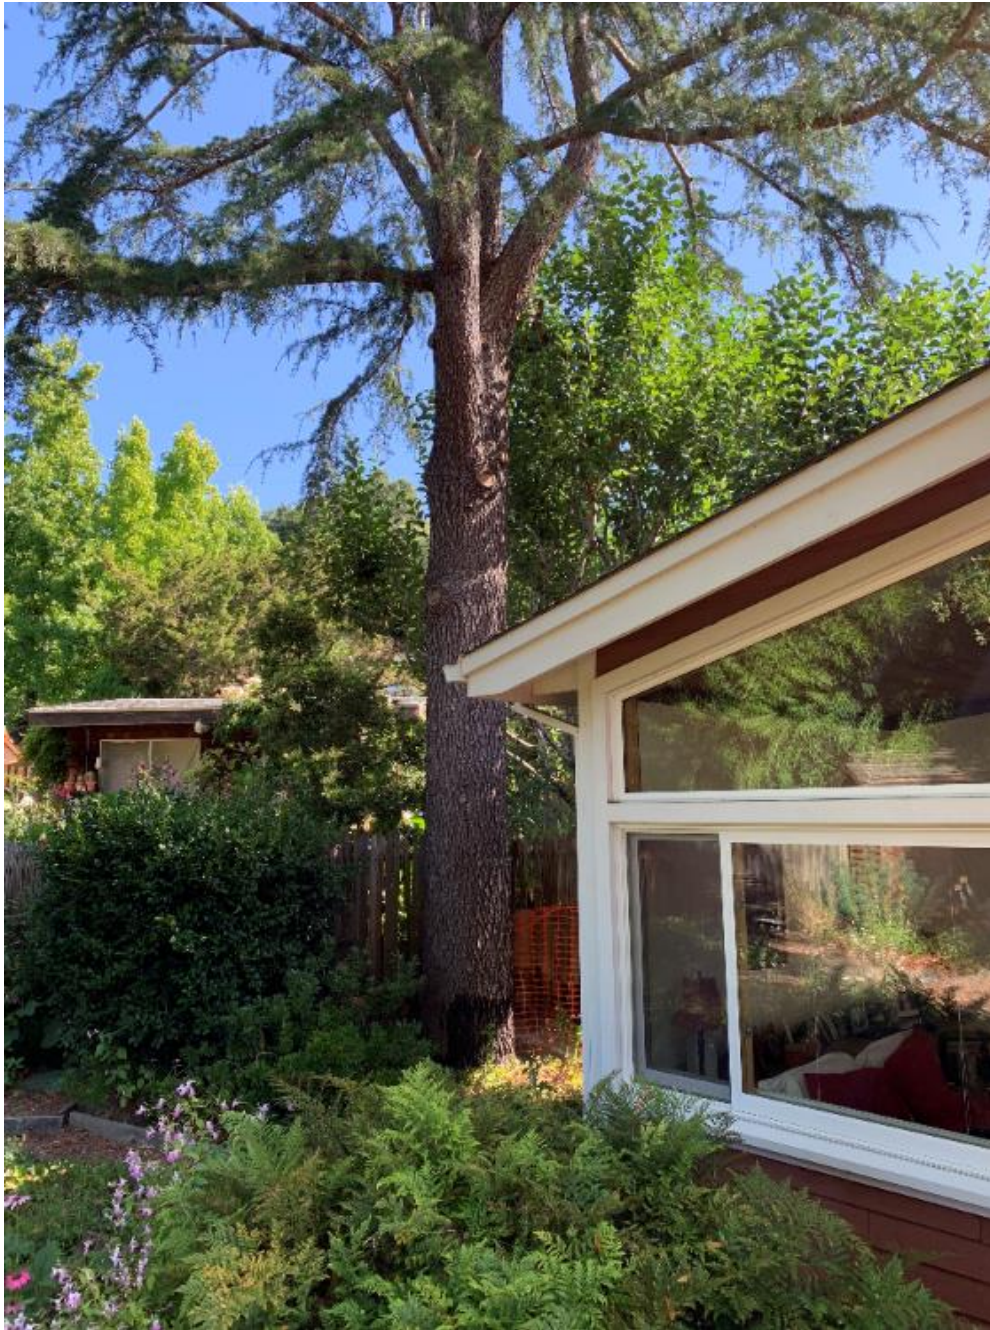
**Figure 2. Subject tree as viewed from the southwest. ADU at 15 Cottage visible in foreground.**

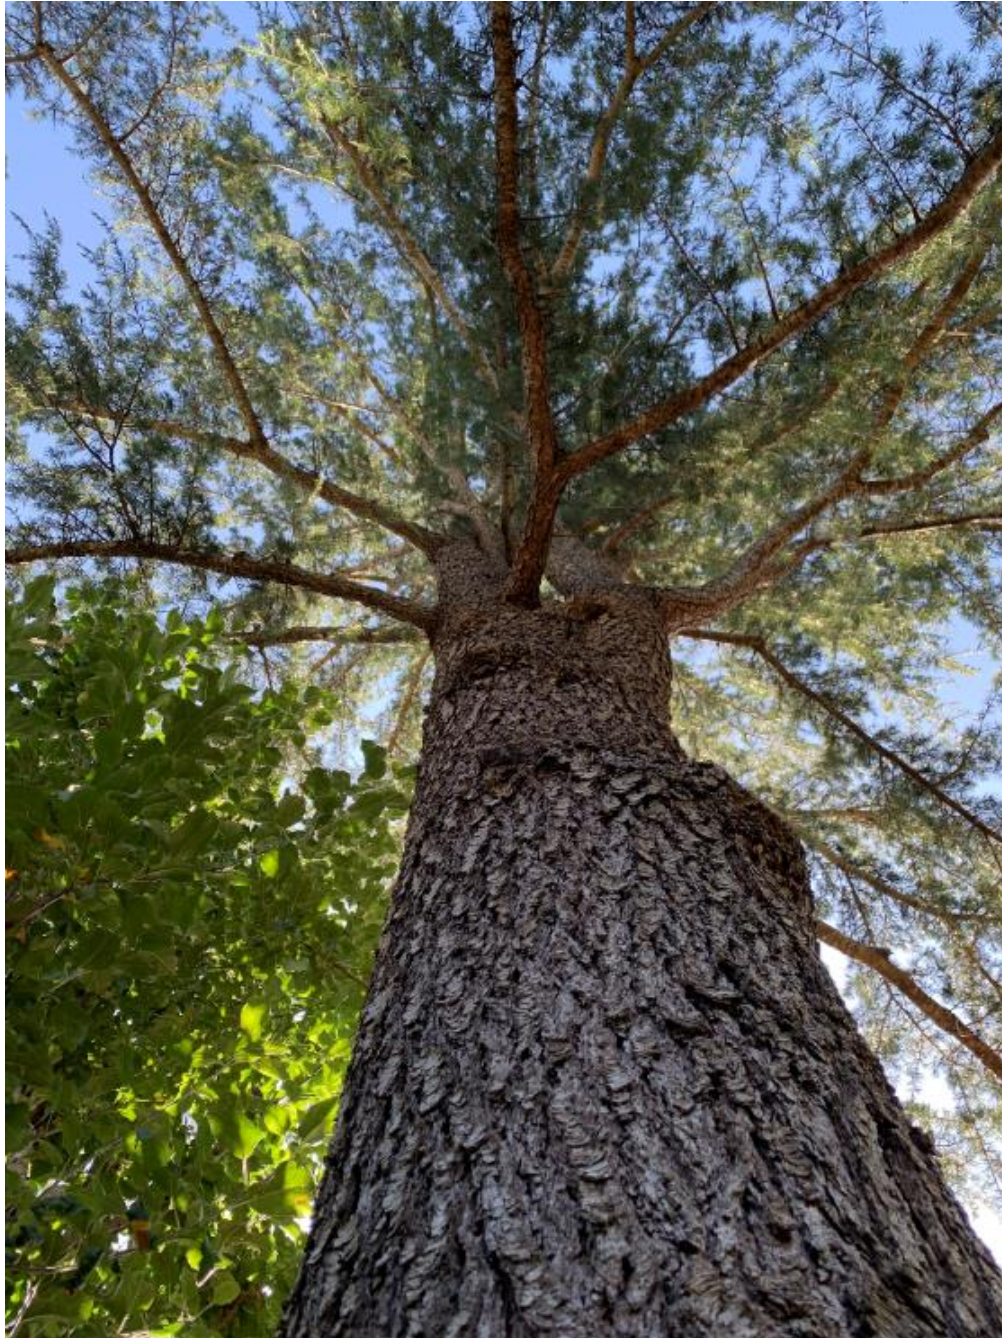
FIRESafe Marin recommends removing all pines in the defensible space zone of a structure. Deodar cedar is not a pine, but it related and shares many of the characteristics that make pines considered fire prone (high surface to volume ratio in the foliage and large canopies producing prolific needle droppings). Deodar cedar is a very large species and this tree is growing in a narrow strip between two retaining walls. The trunk will soon be in contact with the upper wall unless it is modified in the near future.

**Figure 3. Photo showing codominant stems in the canopy.**

It is a reasonable management option to remove this tree due to the fire risk posed by the accumulated needle debris as well as the structural defects in the canopy that are beyond the point of an easy correction through pruning and will pose an increasing risk of failure.

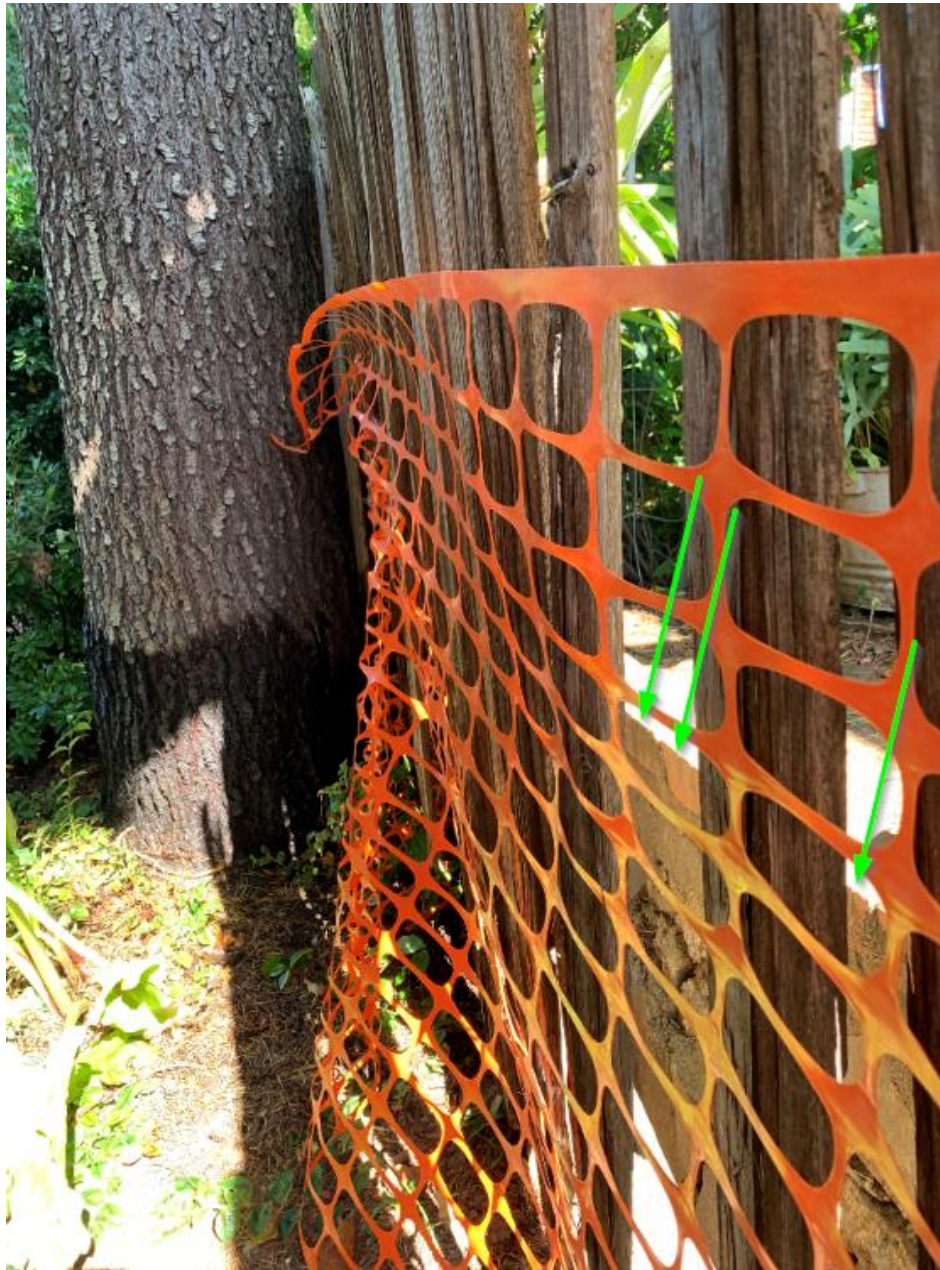
Species	Deodar cedar
Diameter	23.6 inches
Location	See map in Figure 1 and photo in Figure 2. The tree is located on the apparent property line between 15 and 19 Cottage Avenue. There is a short retaining wall adjacent to the base of the tree that raises grade on the 19 side of the fence (Figure 4). There is another short retaining wall adjacent to the base of the tree that lowers grade on the 15 side of the fence. The base of the tree is approximately six feet from the auxiliary dwelling unit at 15 Cottage.
Health	Good. See explanation of condition ratings in Table 1.
Structure <sup>1</sup>	Fair. The tree has many codominant stems <sup>2</sup> (Figure 3), which is common for the species.
Form <sup>3</sup>	Good.
Fire	Both properties are in the Wildland Urban Interface (marinmap.org). Shed needles were accumulated all around the property (Figure 5), despite a reported active campaign to keep the property clean. Branches from the subject tree extend over the roof of the ADU.

**Figure 4. Base of subject tree as viewed from the east-southeast. Top of retaining wall on 19 Cottage indicated with green arrows.**

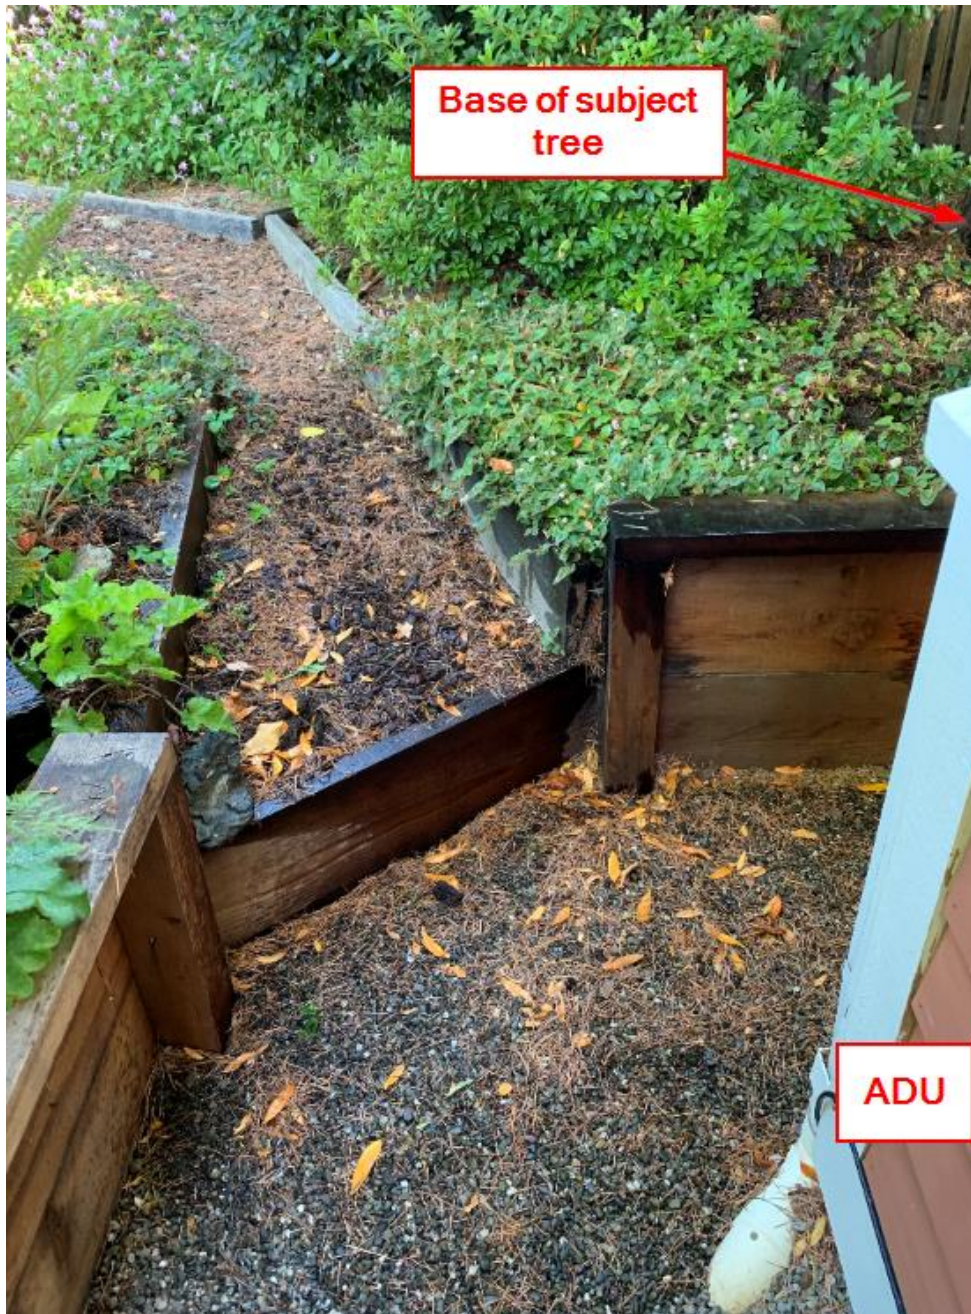
Figure 5. Photo showing needle debris. ADU visible in lower right. Base of tree indicated with red arrow. Lower retaining wall also visible.
