URBAN FORESTRY ASSOCIATES, INC.

ARBORIST REPORT

Jason Eyer, 21 Melville Ave, San Anselmo, CA 94960

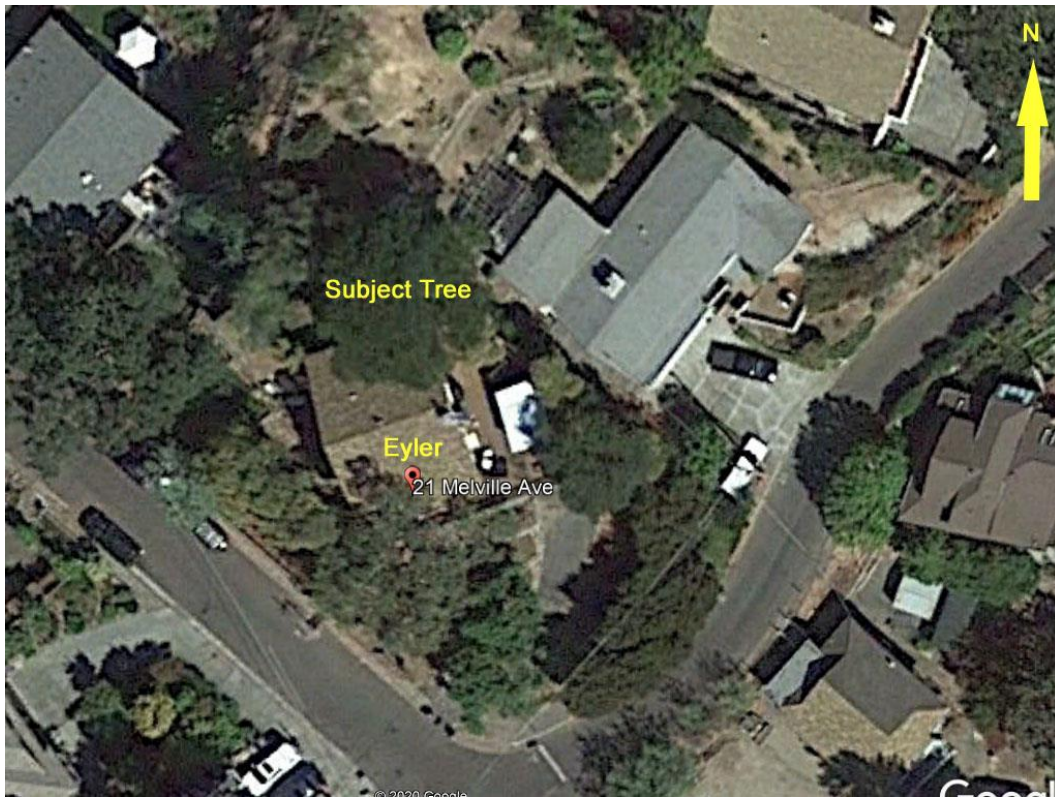
Figure 1 – The Subject Live Oak tree is located by the NE corner of the Eyer home.

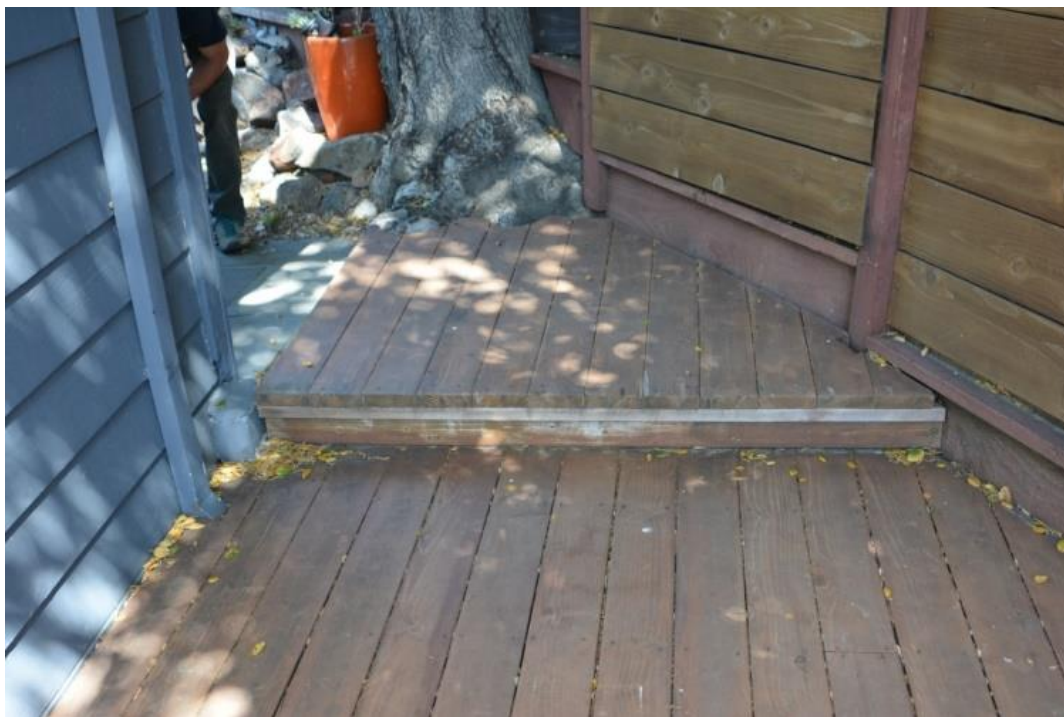
1. The house foundation and the home itself is lifted at the NE corner adjacent to the subject tree.
2. The close proximity of the tree and structural root system to the foundation inhibits the replacement of the old foundation at the NE corner.
3. The old foundation is spalled and cracked.
4. The sidewalk and back walk are lifted by the tree roots creating a high tripping risk.
5. The root system of the tree is limited by the foundation and other adjacent infrastructure.

Figure 2 – The root system is limited by the house foundation and infrastructure.

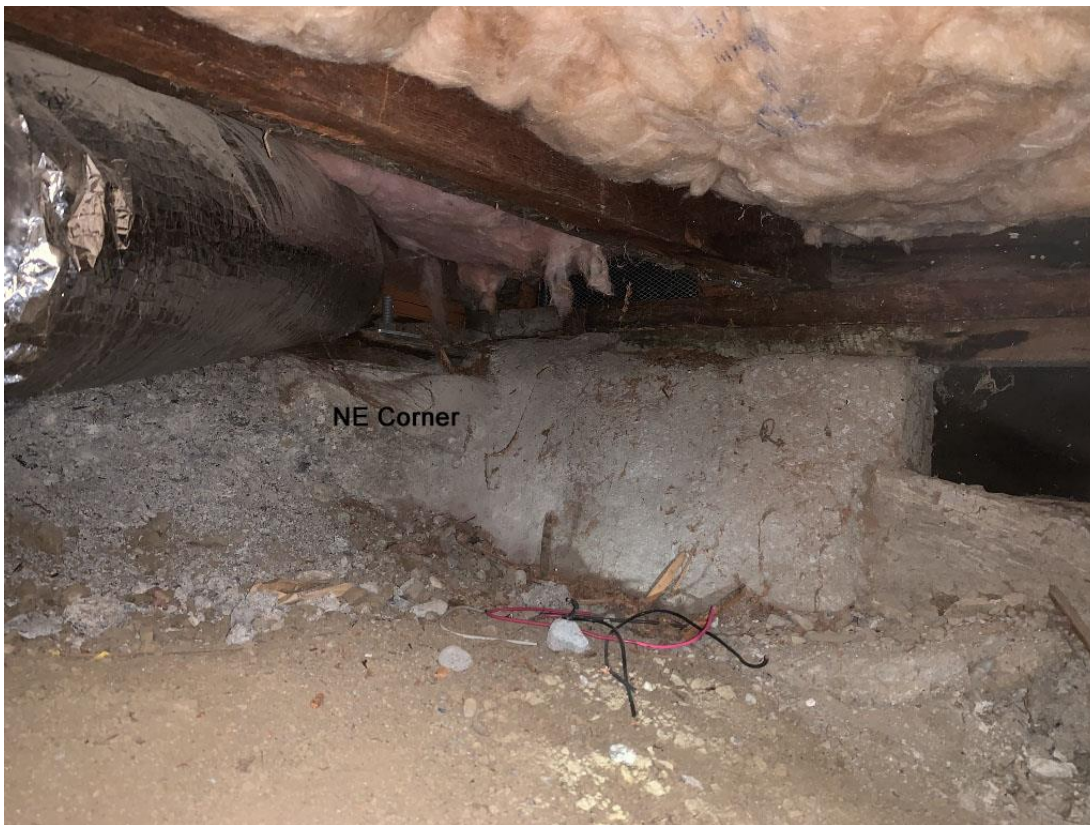
Figure 3 – The tree is within 3.8' of the NE corner of the old foundation and is lifting and breaking it.

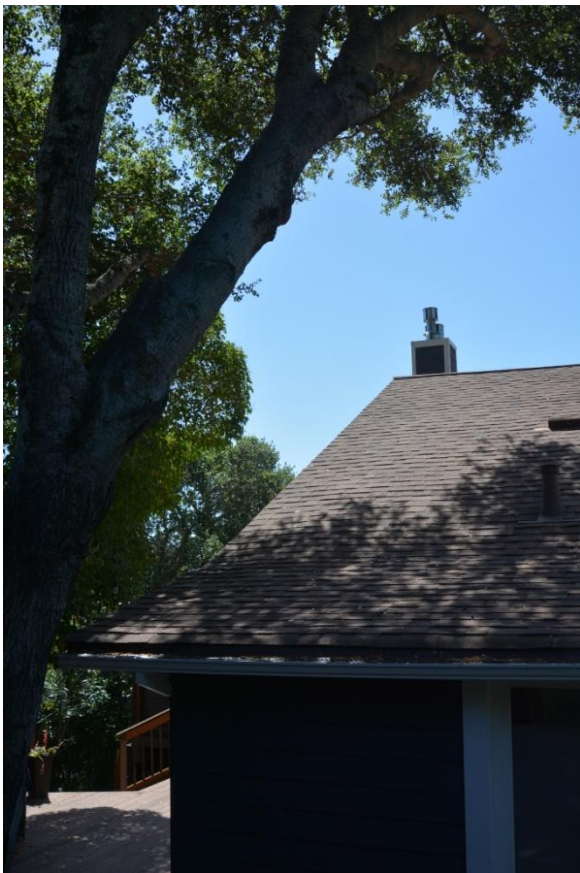
< Figure 4 – The lean and balance of the tree is toward the home

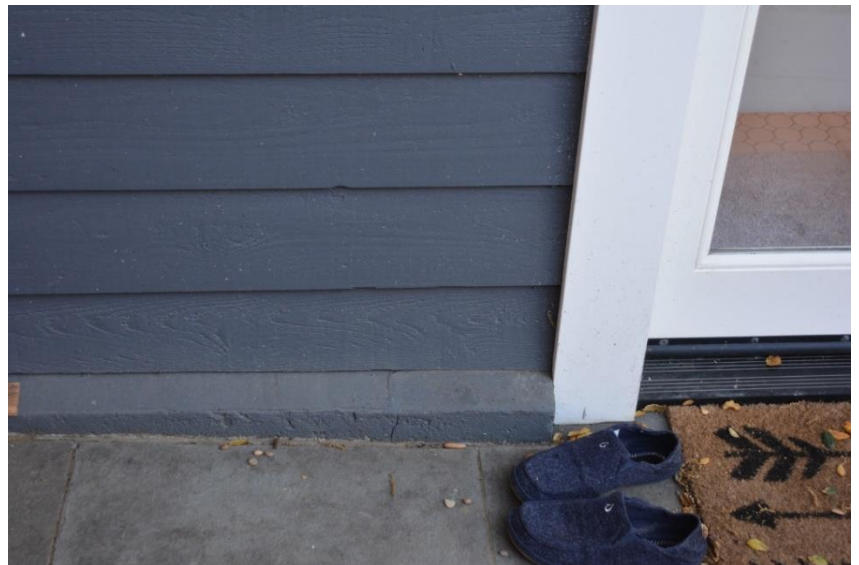
Figure 5 (above)- The back sidewalk is lifted and the foundation is cracked about 4 feet from the NE corner of the Eyler home.

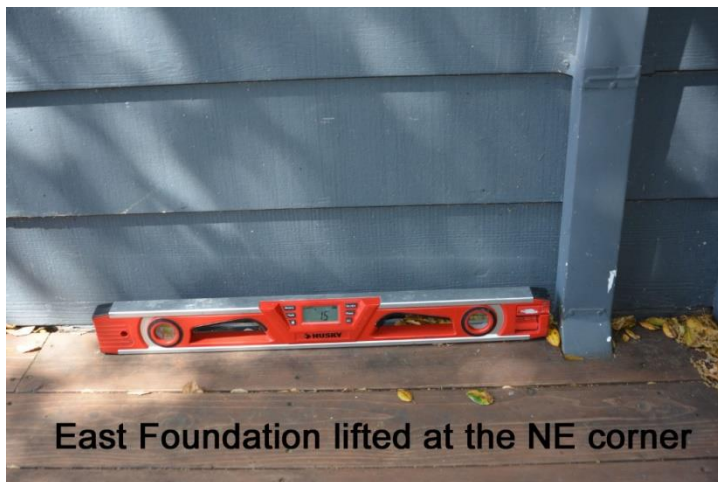
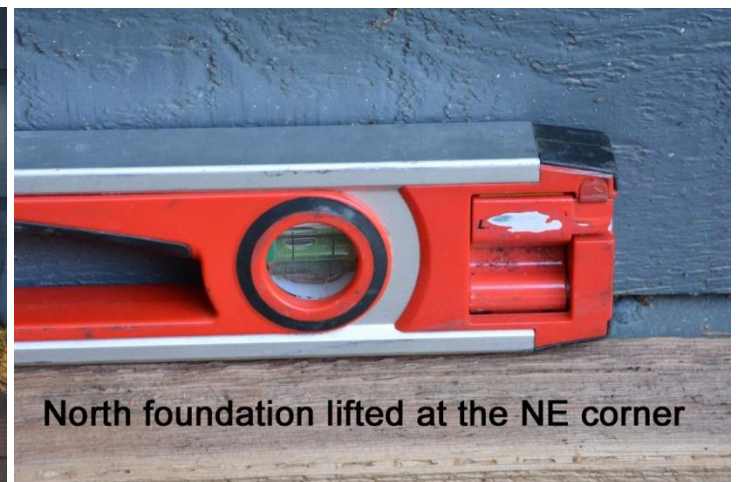
Figure 6a & b – The east and north foundation sections are lifted toward the NE corner and subject oak tree.

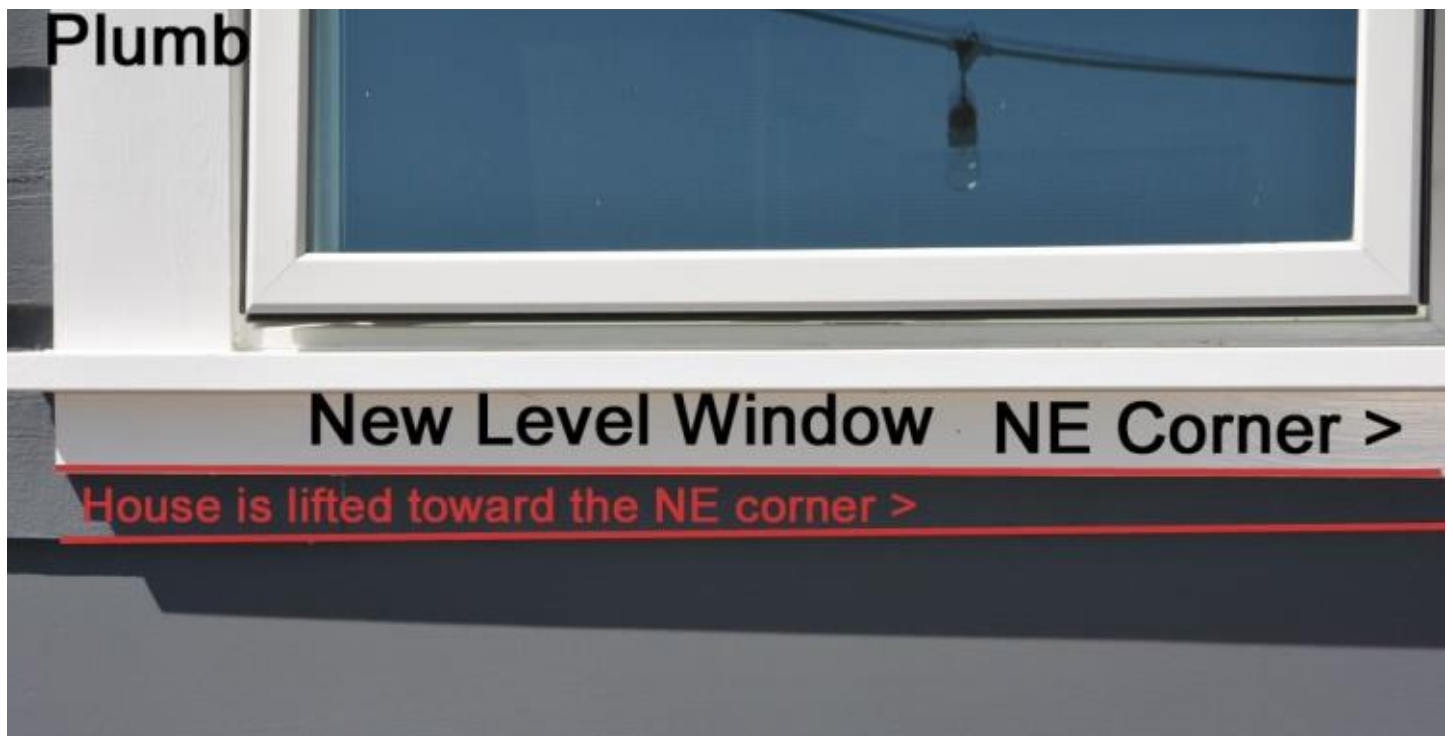
Figure 7 – The out-of-level siding relative to the new level shows the Eyler home is higher at the NE corner.
