Client: Mary Breeze

Project Address: 28 Elkhorn Way, San Anselmo

Inspection Date: June 3, 2020

ASSIGNMENT/ BACKGROUND

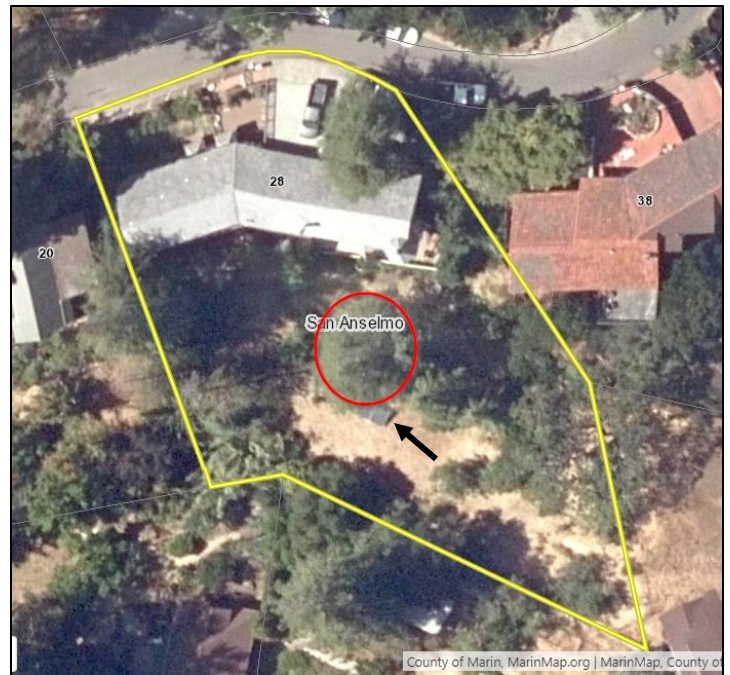
Location In the back yard on a slope below the home (Figure 1, 2).

Figure 1. Aerial image of 28 Elk Horn Way indicating parcel lines and approximate canopy dripline of the subject tree. Black arrow indicates the location of solar panels.

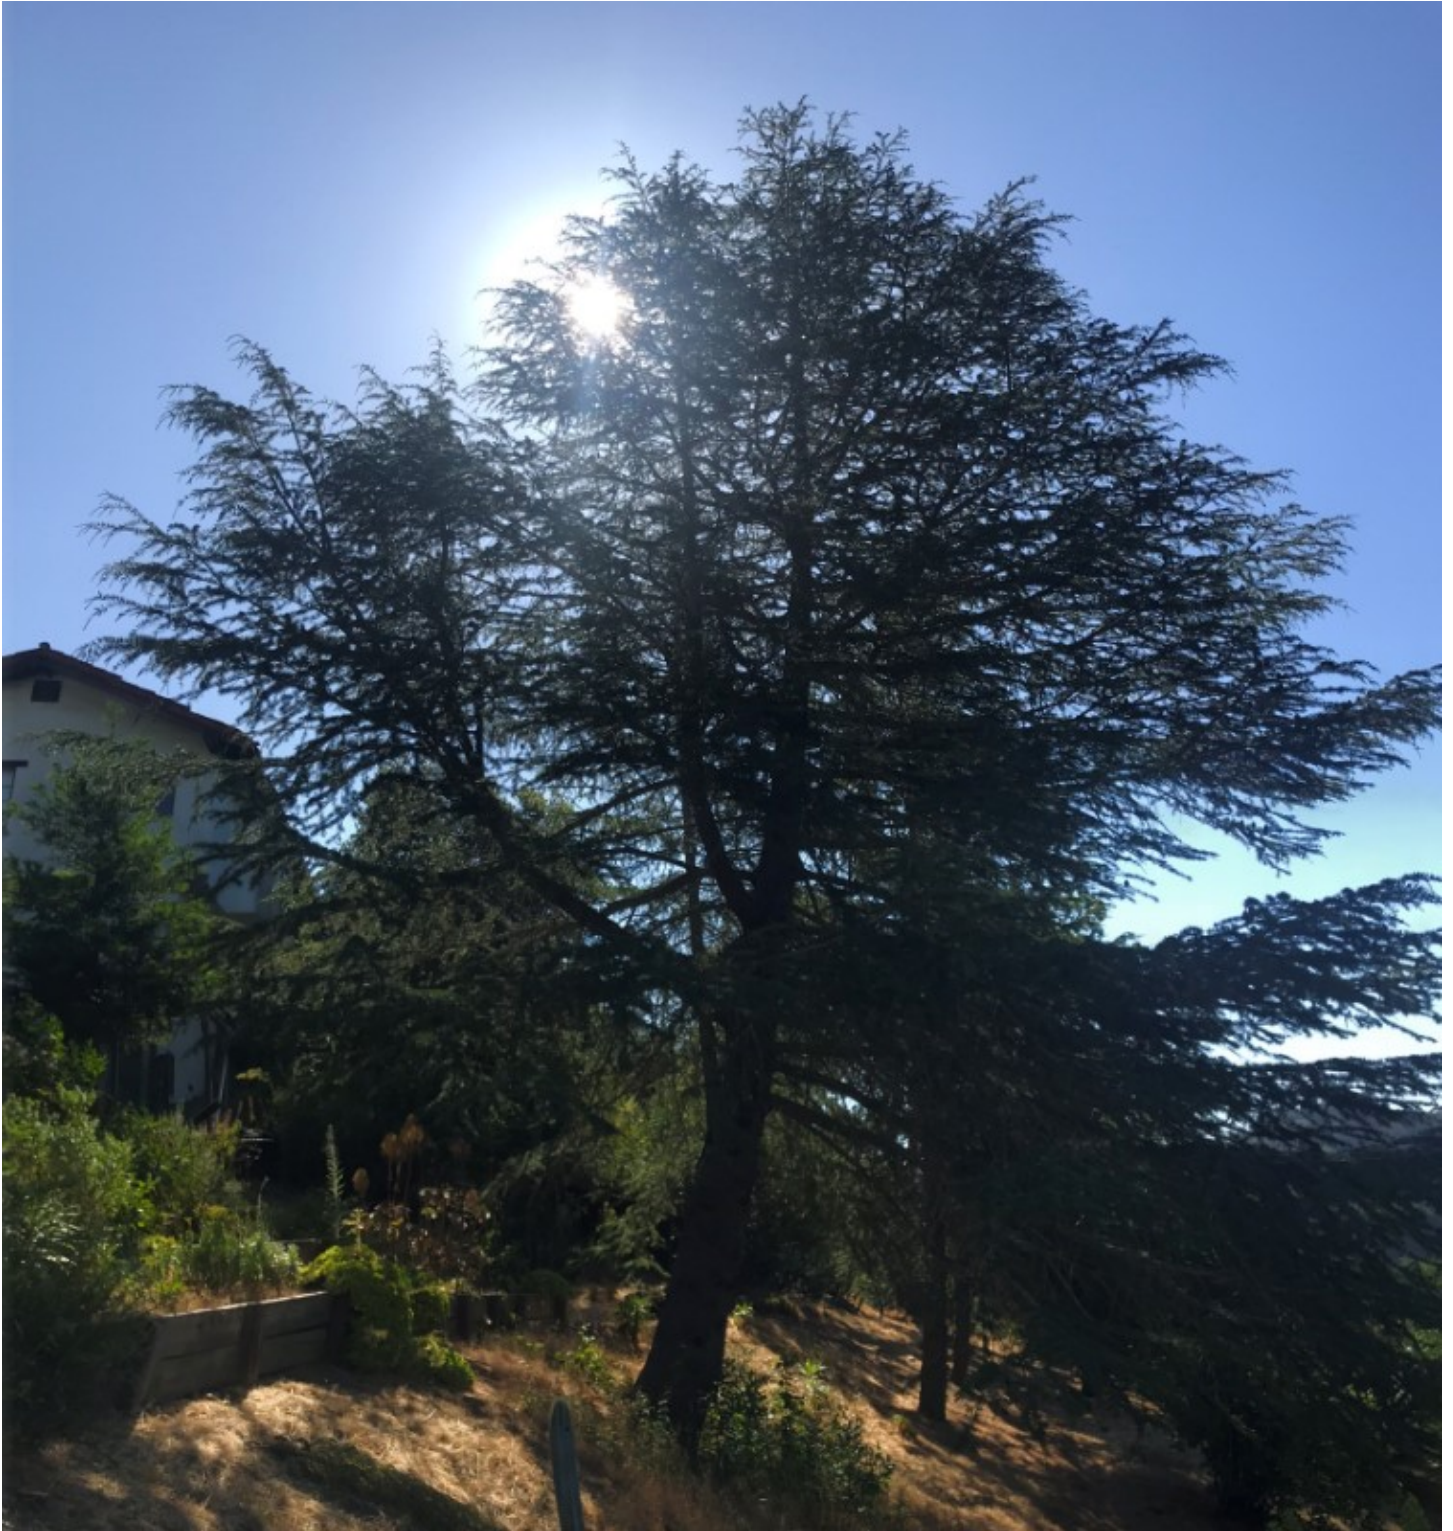
Condition The subject tree is in **good health** and appears stable, with no obvious canopy asymmetry or lean. The subject tree is one of many deodar cedars on the slope, all of which are reportedly volunteers. The group of trees form a continuous mass of canopy in the southeast portion of the property.

Figure 2. Subject tree viewed from the backyard

To abate the issues described above, remove the subject tree and additional non-heritage cedars.

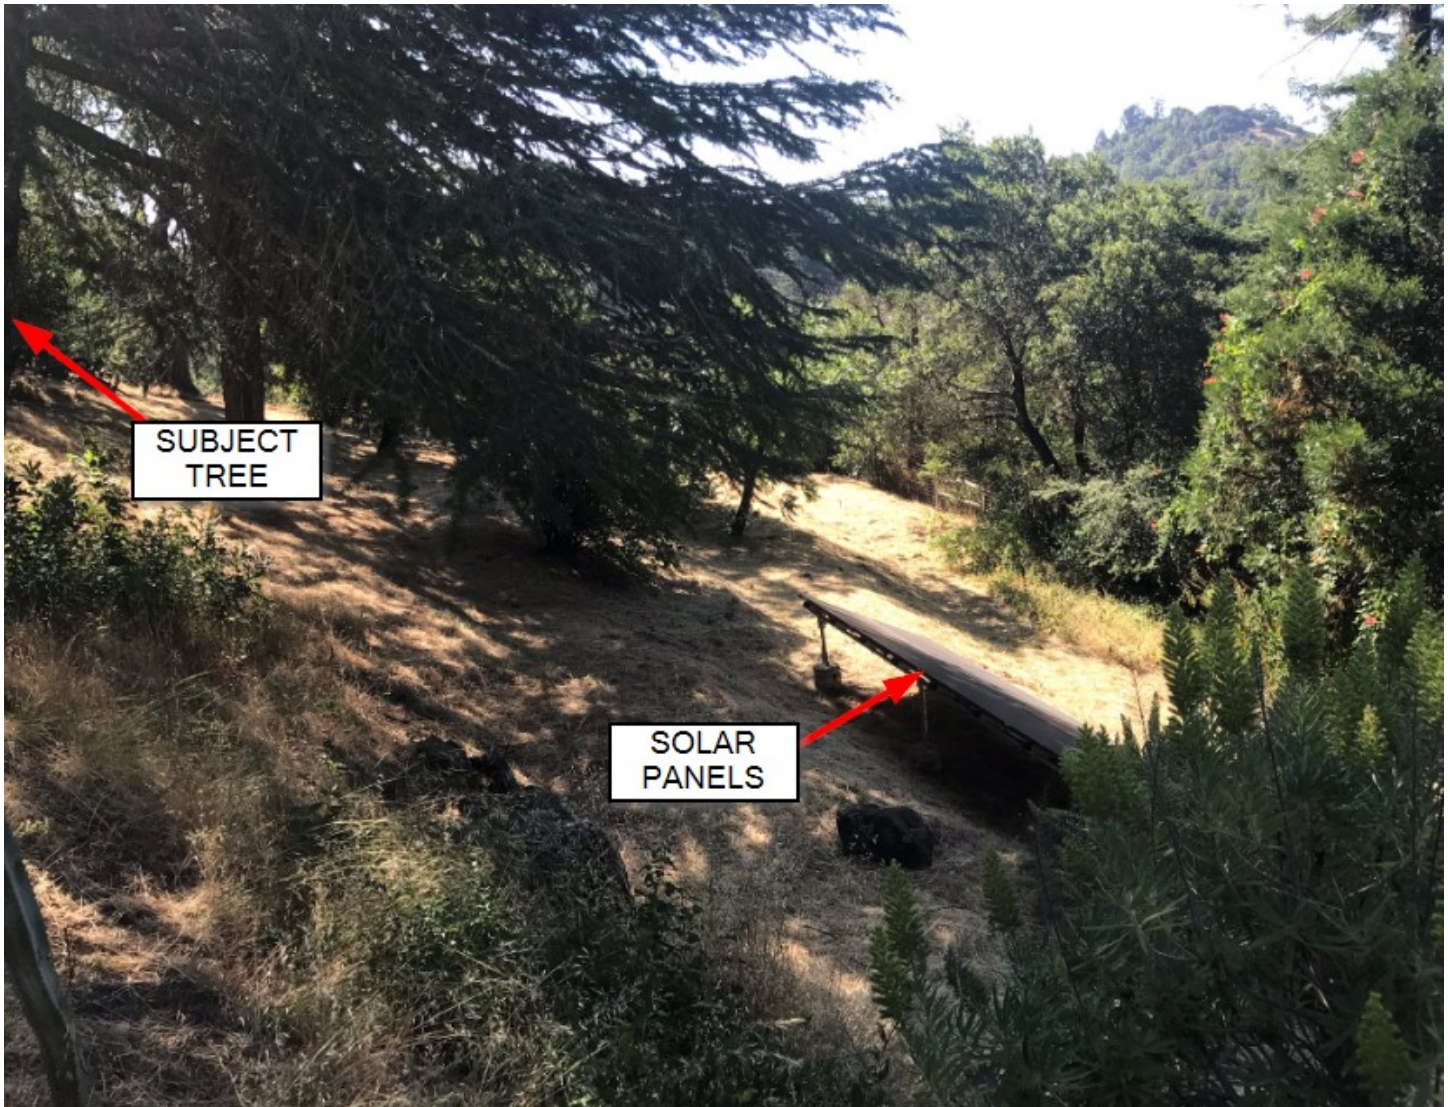
Figure 3

There is a solar panel array installed on the slope south of the tree. Cones from the subject tree reportedly impact the panels (Figure 3).
