URBAN FORESTRY ASSOCIATES, INC.

ARBORIST REPORT

***Att: Joanna MeGee First Presbyterian Church of San Anselmo
72 Kensington Road, San Anselm, CA 94960***

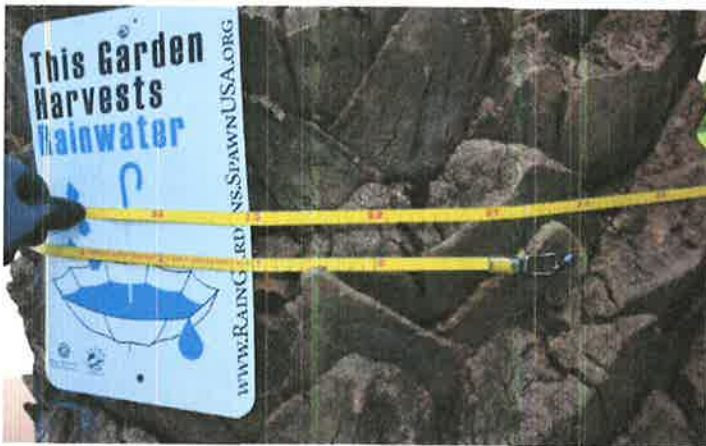
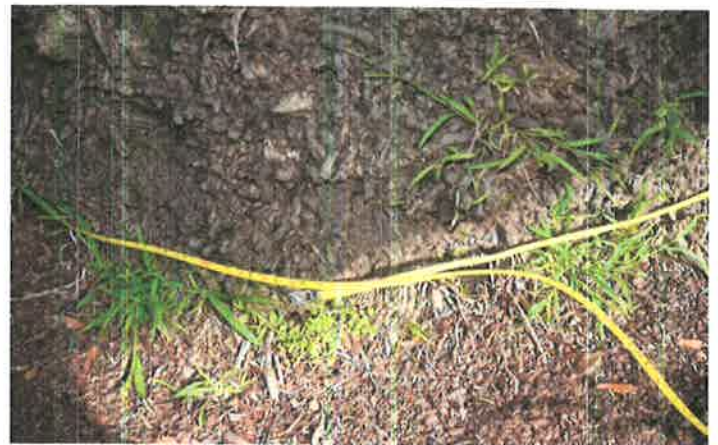
Species Canary Island Palm (*Phoenix canariensis*) WC ISA Appraisal Class 2 Group \$375TF
Size 32" DBH Height, DGL ≈ 55.4", CGL = 14.35' (See Figure 2)
Location In a garden surrounded by a building and covered walkway (See Aerial Map, Figures 1a & 1b)
Condition Very good health, good / typical structural condition. The tree base is 3' from the sidewalk and five feet from the building corner (Figure 3). Concern about annual dead frond maintenance, debris on roofs and rat habitat (Figure 4).

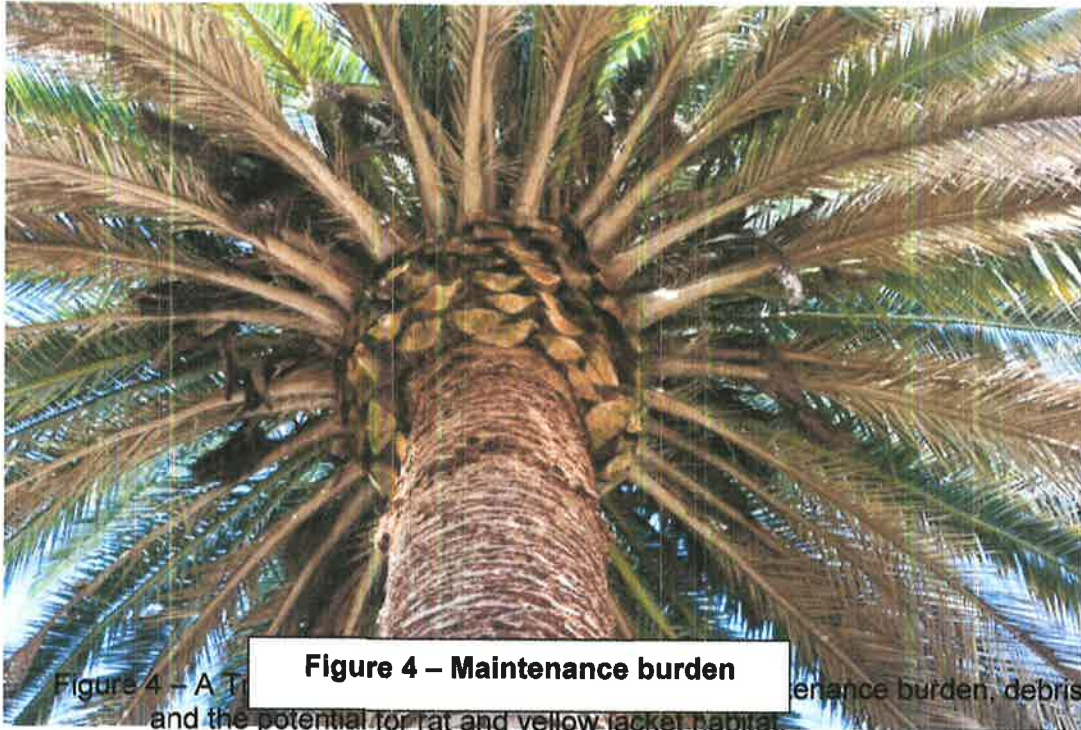
Figure 4 – Maintenance burden
Figure 4 – A T... maintenance burden, debris, and the potential for rat and yellow jacket habitat.

Conclusions: In my experience this species does, in fact, provide habitat for rats and yellow jackets, and sometimes excessive debris and bird droppings. Together with the removal of dead fronds and debris for fire safety I can understand the concerns about the maintenance burden.
