**Client:** All Seasons Tree Care

**Project Address:** 85 Melville Ave., San Anselmo

**Inspection Date:** August 7, 2020

## ASSIGNMENT/ BACKGROUND

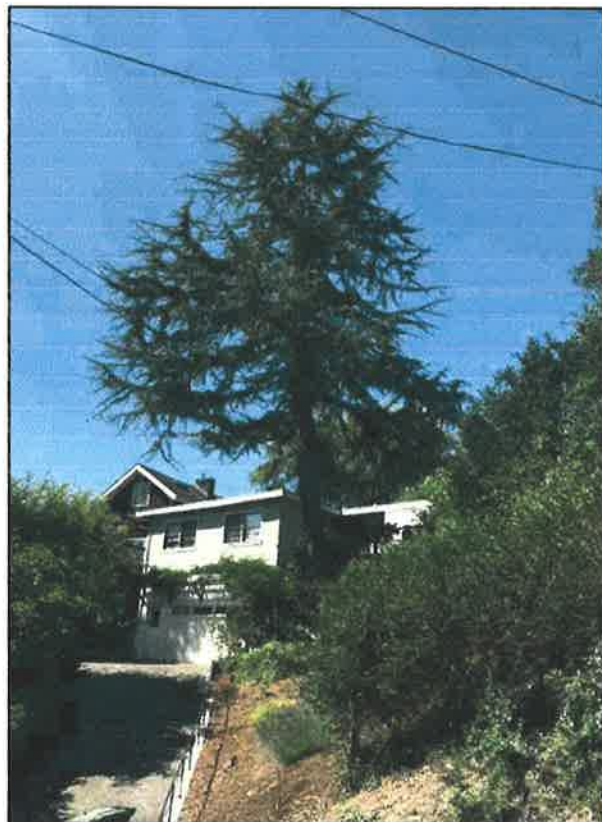
Species	deodar cedar ( <i>Cedrus deodara</i> )
Size	The tree stands approximately 40 feet tall. The trunk diameter measures 25.2 inches dbh <sup>1</sup> , qualifying as Heritage per San Anselmo Municipal Code.
Location	Front yard on the slope just below the brick pathway (Figure 3).
Condition	
Health	<b>Good.</b> No canopy dieback or significant deadwood in the canopy.
Structure	<b>Good.</b>
Form	<b>Good.</b>

Figure 1. Subject tree as viewed from the road.

Whole tree removal to abate all fire risk associated with the tree.

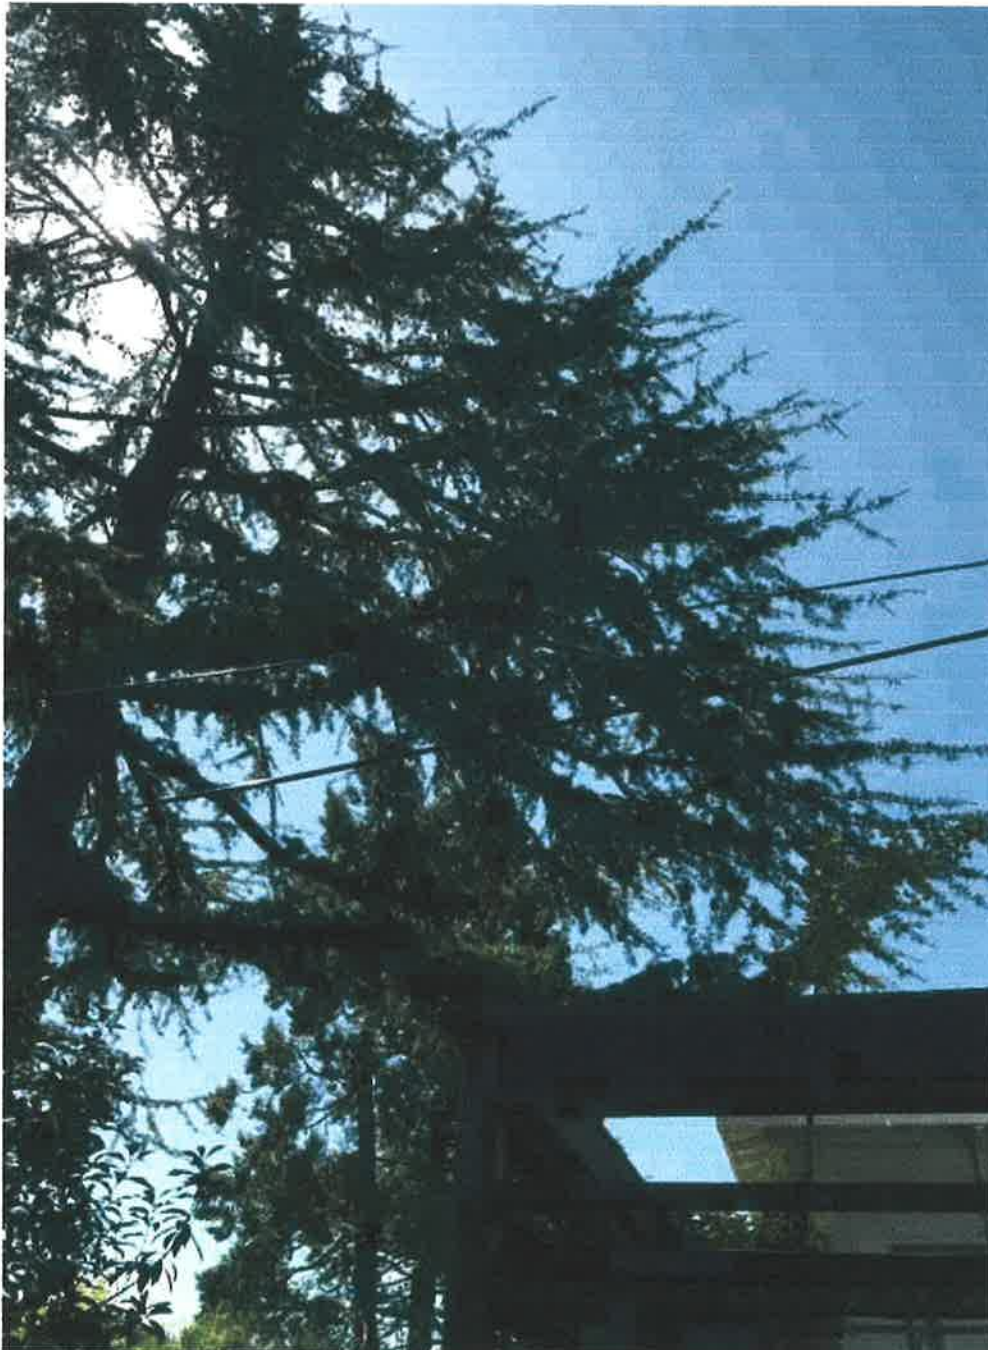
The subject tree is poorly located near the home which has required frequent pruning to maintain clearance. Deodar cedar is considered fire prone and thus not ideal for compact properties within the WUI. For these reasons it is reasonable to remove the tree to mitigate the elevated fire risk it poses.

Figure 2. Proximity of the canopy to the home and roof.
