**URBAN FORESTRY ASSOCIATES, INC.**

**PINE TREE NUISANCE ASSESSMENT ARBORIST REPORT**

*Allan Ashton – 29 Grove Lane, San Anselmo, CA 94965*

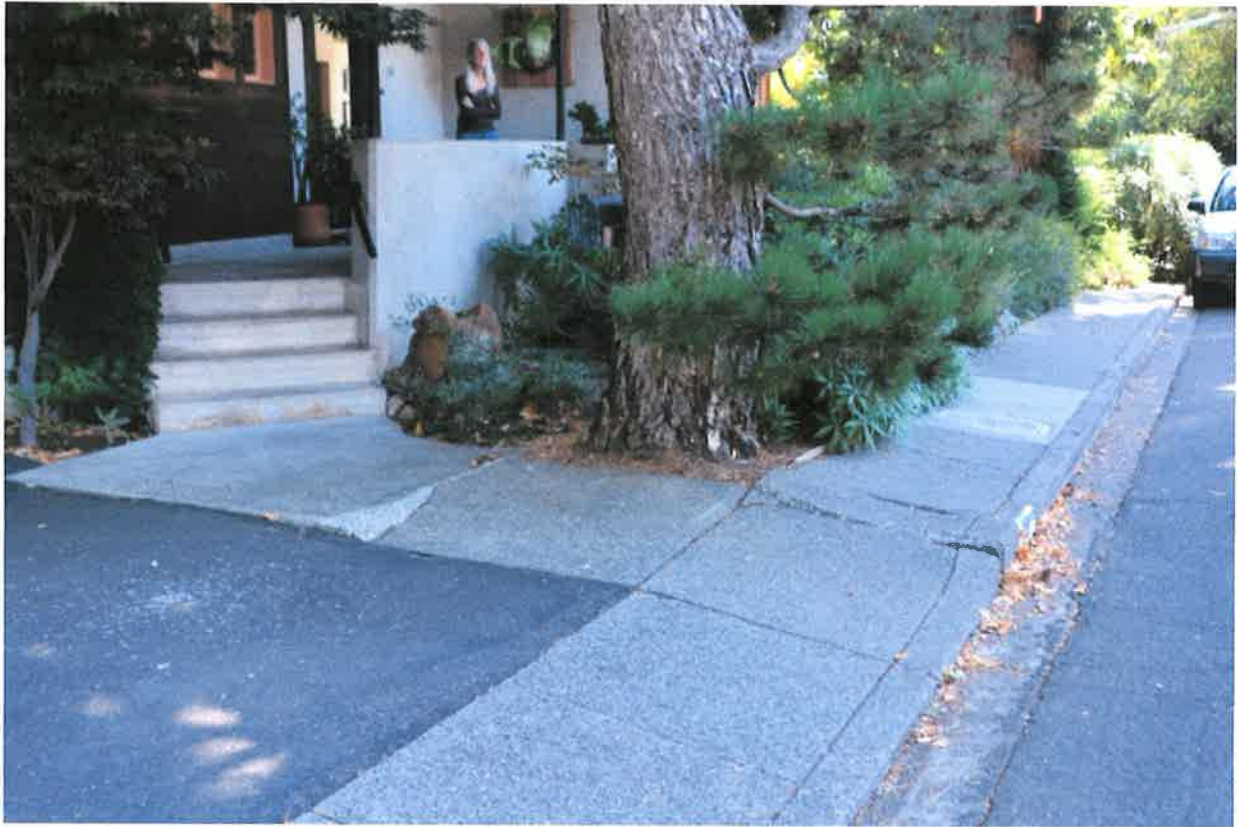
Species	c.f.Scots Pine (c.f. <i>Pinus sylvestris</i> )
Size	24.4" DBH <sup>1</sup>
Location	At the intersection of the front entrance walk and the public sidewalk. It is pressuring both sidewalks, uplifting the drainage line and an adjacent utility line. (See Figure 1)
Condition	Good health, Good structural condition, Fire Risk - severe. This tree is a prime example of wrong tree, wrong place. This species grows too large for its location. Consequently it is destroying the immediately adjacent infrastructure including the front entrance sidewalk, the home's drainage system, the public sidewalk and the curb Figures 1 & 2. It interferes with pedestrian traffic along the public sidewalk (Figure 1). It is also presents a high fire risk to the home, being a fire-prone species and the fact that it overhangs the roof. Maximum needle drop is in the fall when fire behavior risk meets its highest level. It also presents a potential obstruction to home evacuation, were a wildfire or home fire to occur and ignite the tree (See Figures 1 and 2).

**Conclusions:** The available root zone and potential for infrastructure damage, as well as fire risk, makes this tree's location unsuitable for any tree, much less a species of this tree's size and fire-prone characteristics.

Figure 1 – The subject pine tree is located where it has damaged immediately adjacent infrastructure.

**Recommendation:** Remove to abate the nuisance before the coming fall peak to the fire season.

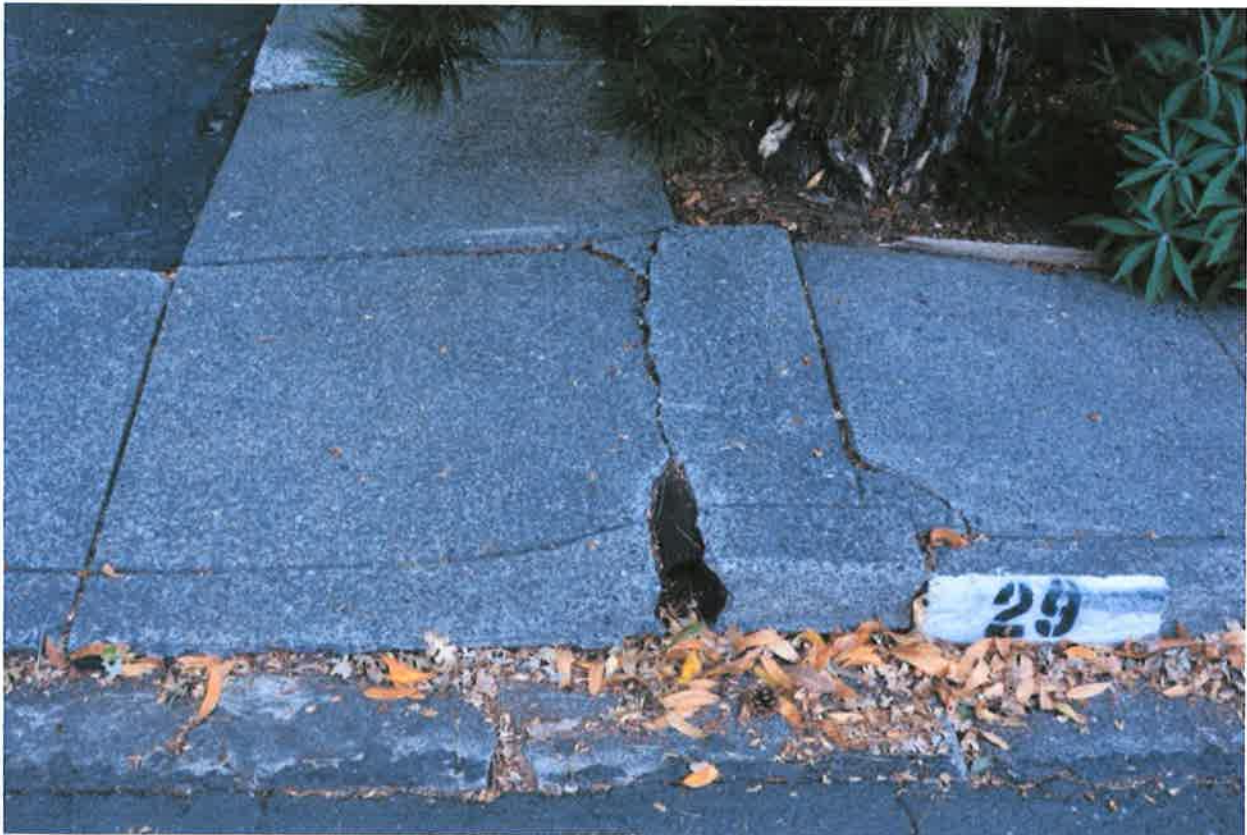
Figure 2 – The uplift of the drainage line has displaced the public sidewalk and curb.
