Client: Dan and Kathleen Hilken

Project Address: 126 Barber Avenue, San Anselmo

Inspection Date: April 26, 2021

ASSIGNMENT/ BACKGROUND

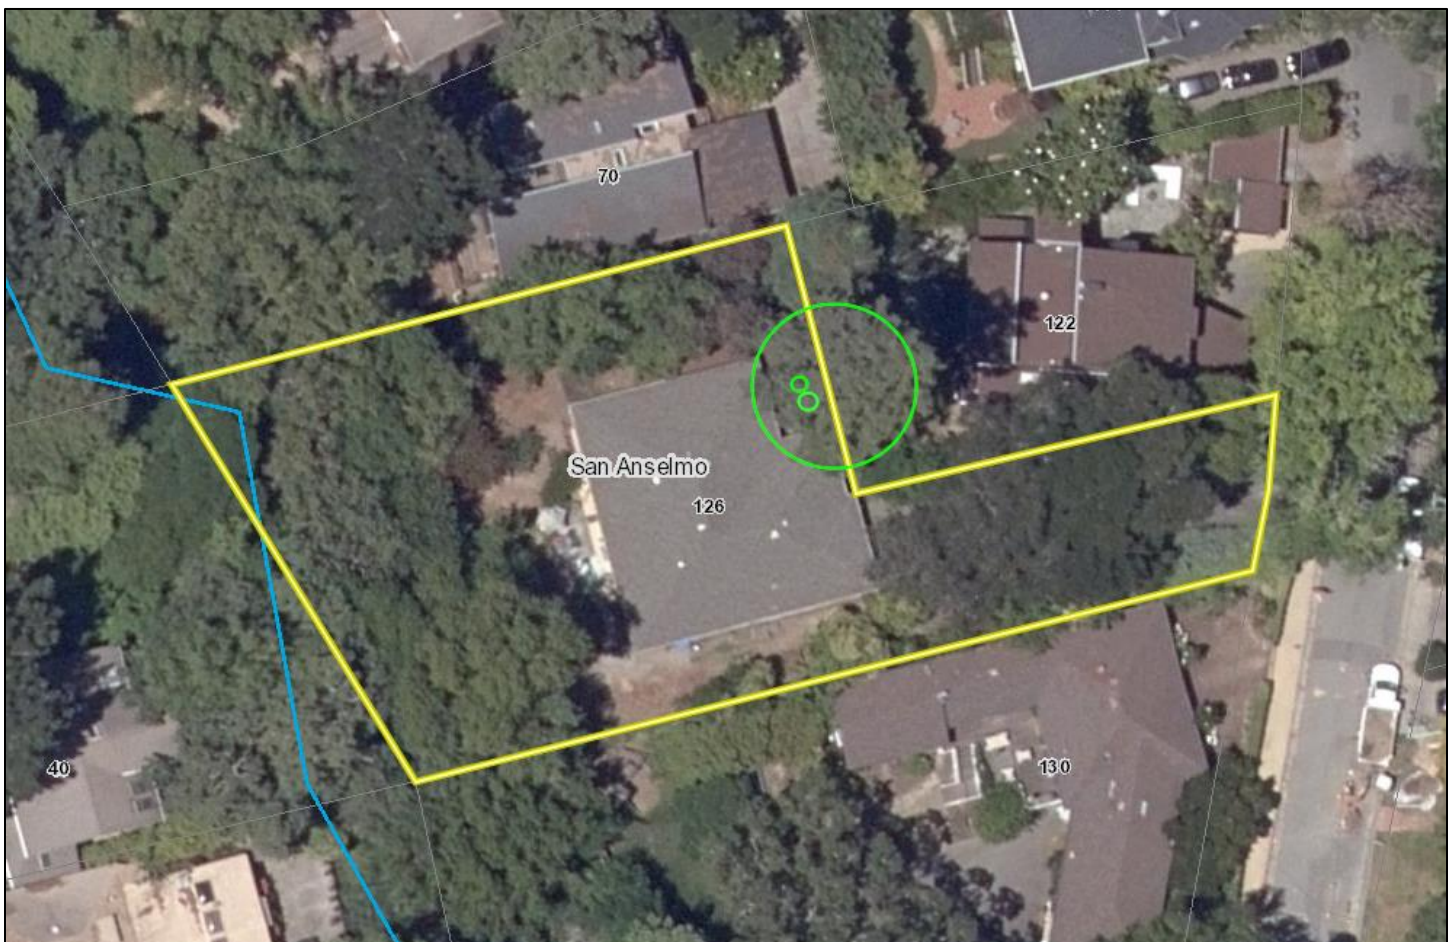
Site Plan indicating the approximate trunk locations and canopy dripline. *Not drawn to scale.

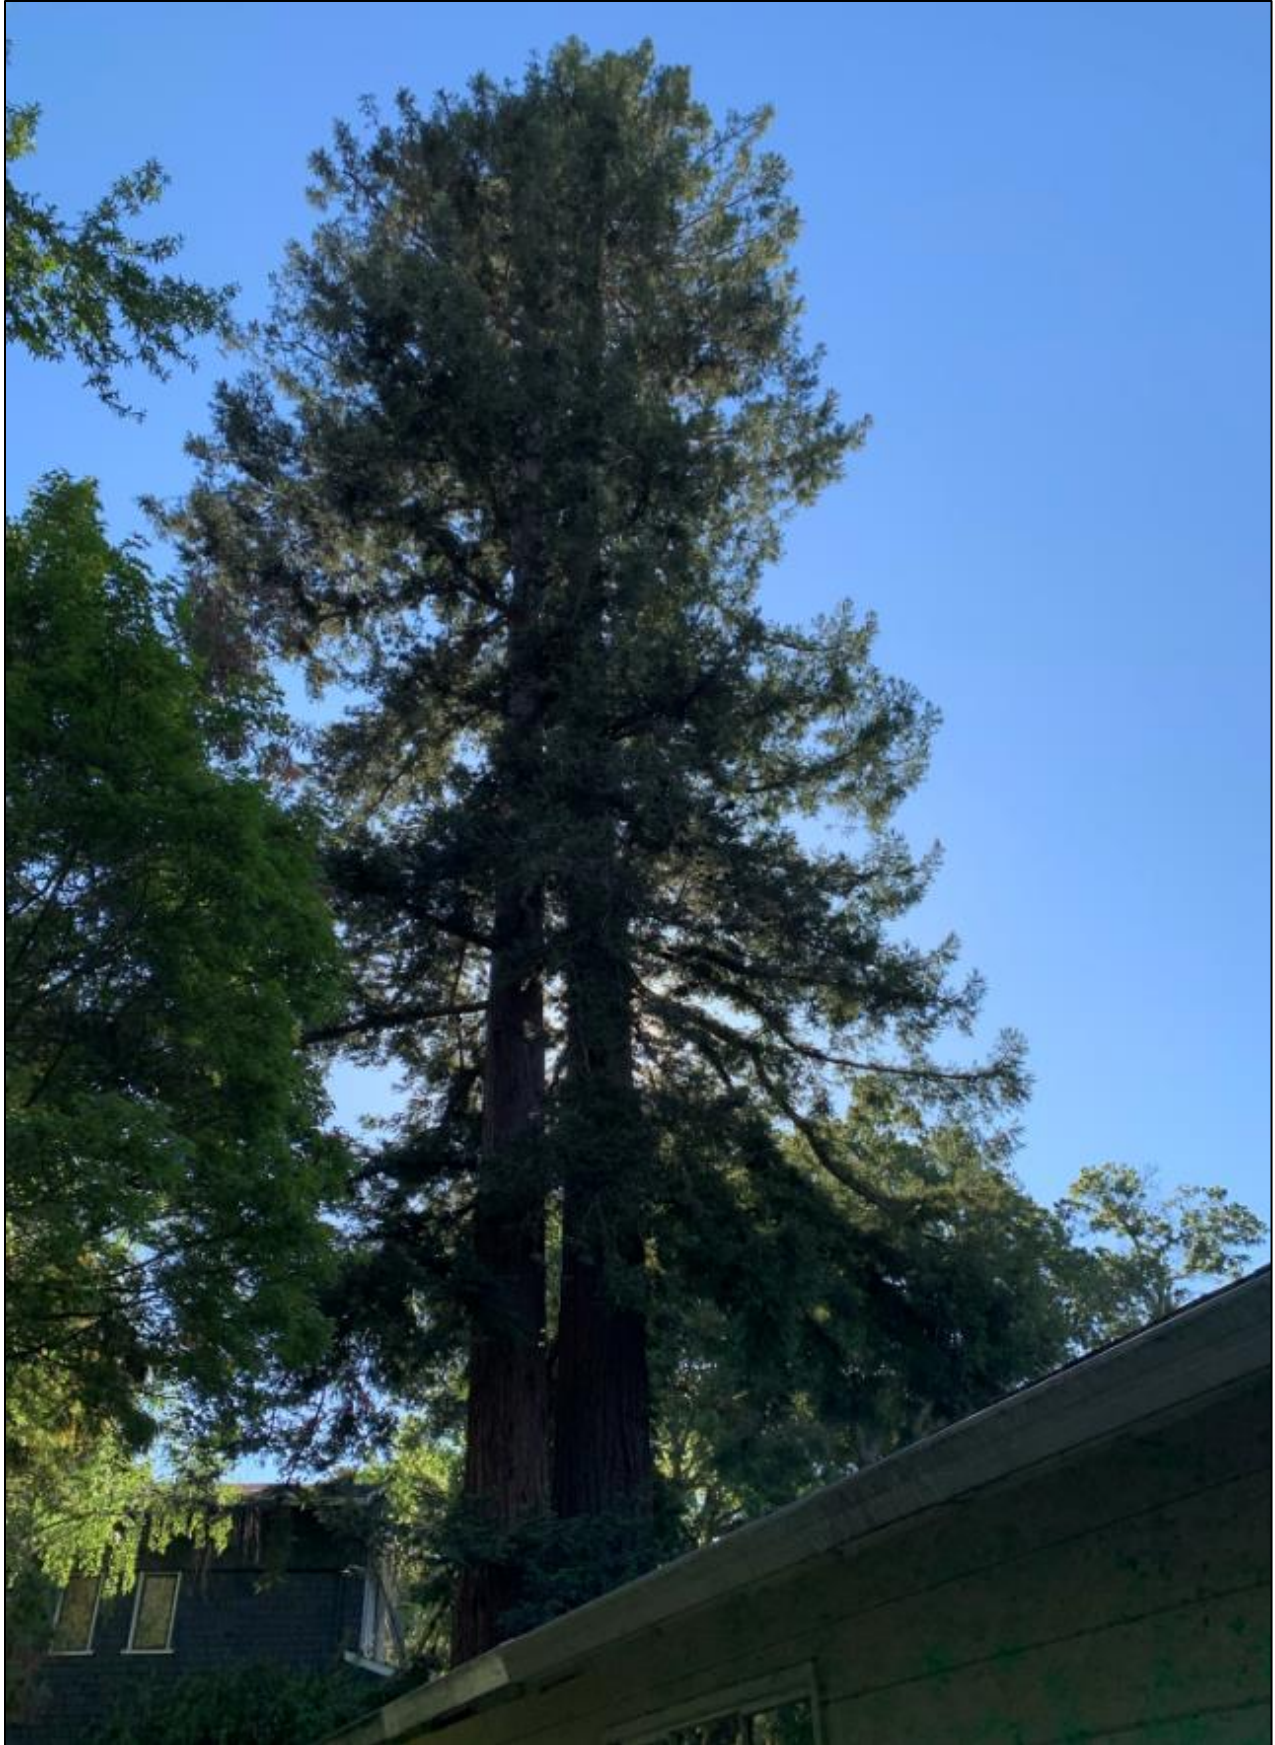
The tree stands approximately 120 feet high, and the canopy extends over the roof of the home. See Figure 1. The tree also targets the parking area near the garage. I am informed a limb from the tree fell and caused significant damage to a renter's vehicle in the past.

Figure 1. The tree as viewed from the backyard

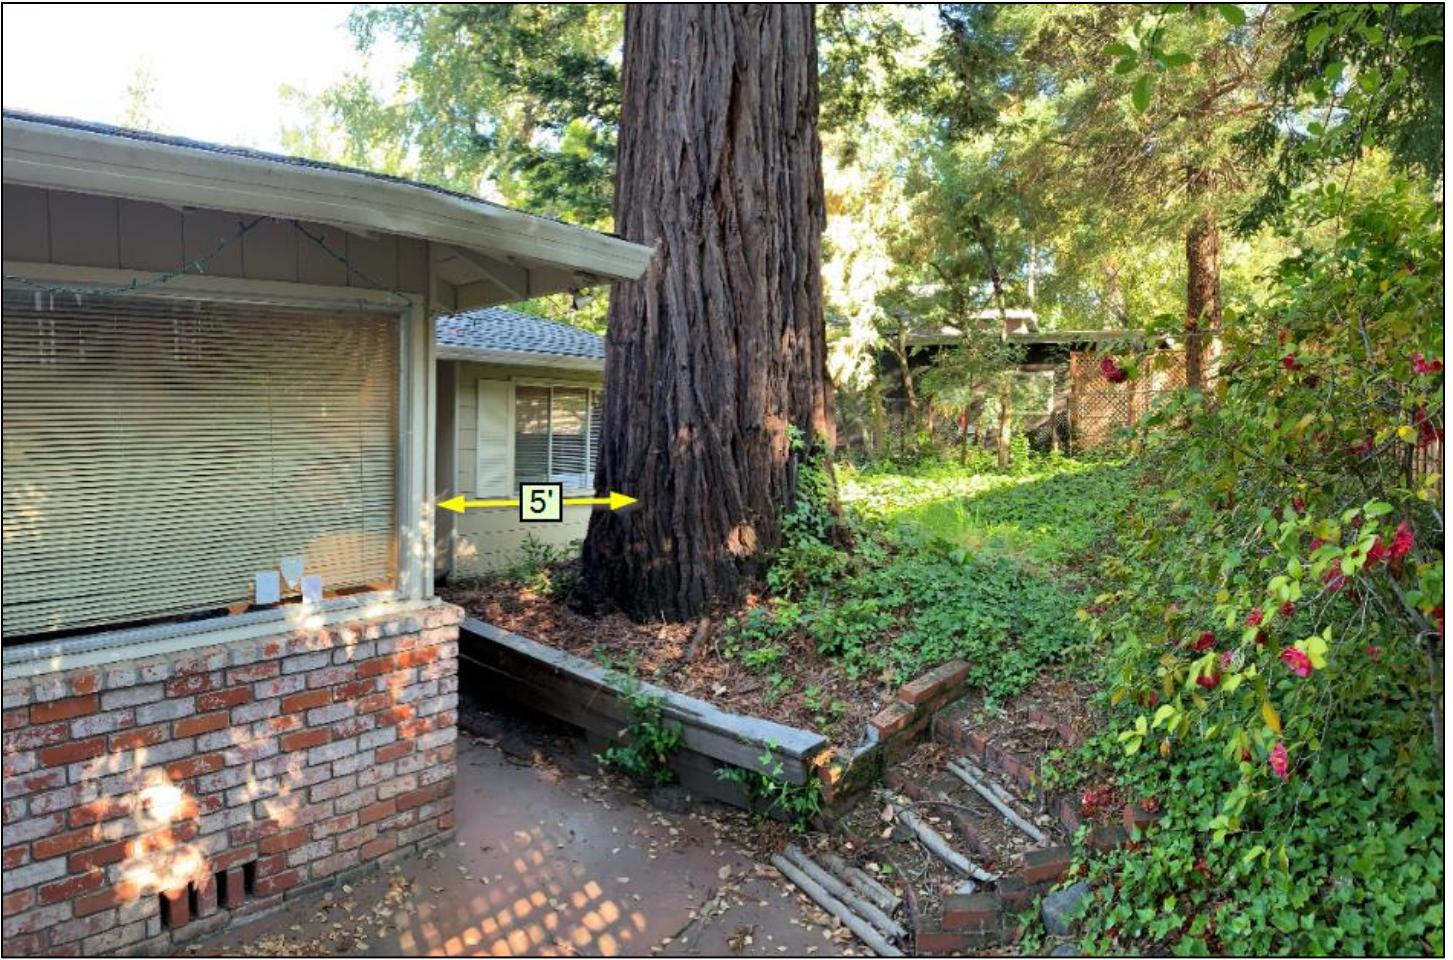
The tree is growing in a raised wooden retaining wall planter near the entryway to the home. The trunk is five feet from the brick siding on the north face of the home. There is a crack in the brick siding. See Figure 3. The trunk is 7 feet from the siding on the east face of the home. Growth from the tree has enveloped part of the walkway. See Figure 4.

Figure 2. Proximity of the tree to the home and entryway

I recommend the tree be removed to abate the issues discussed above.

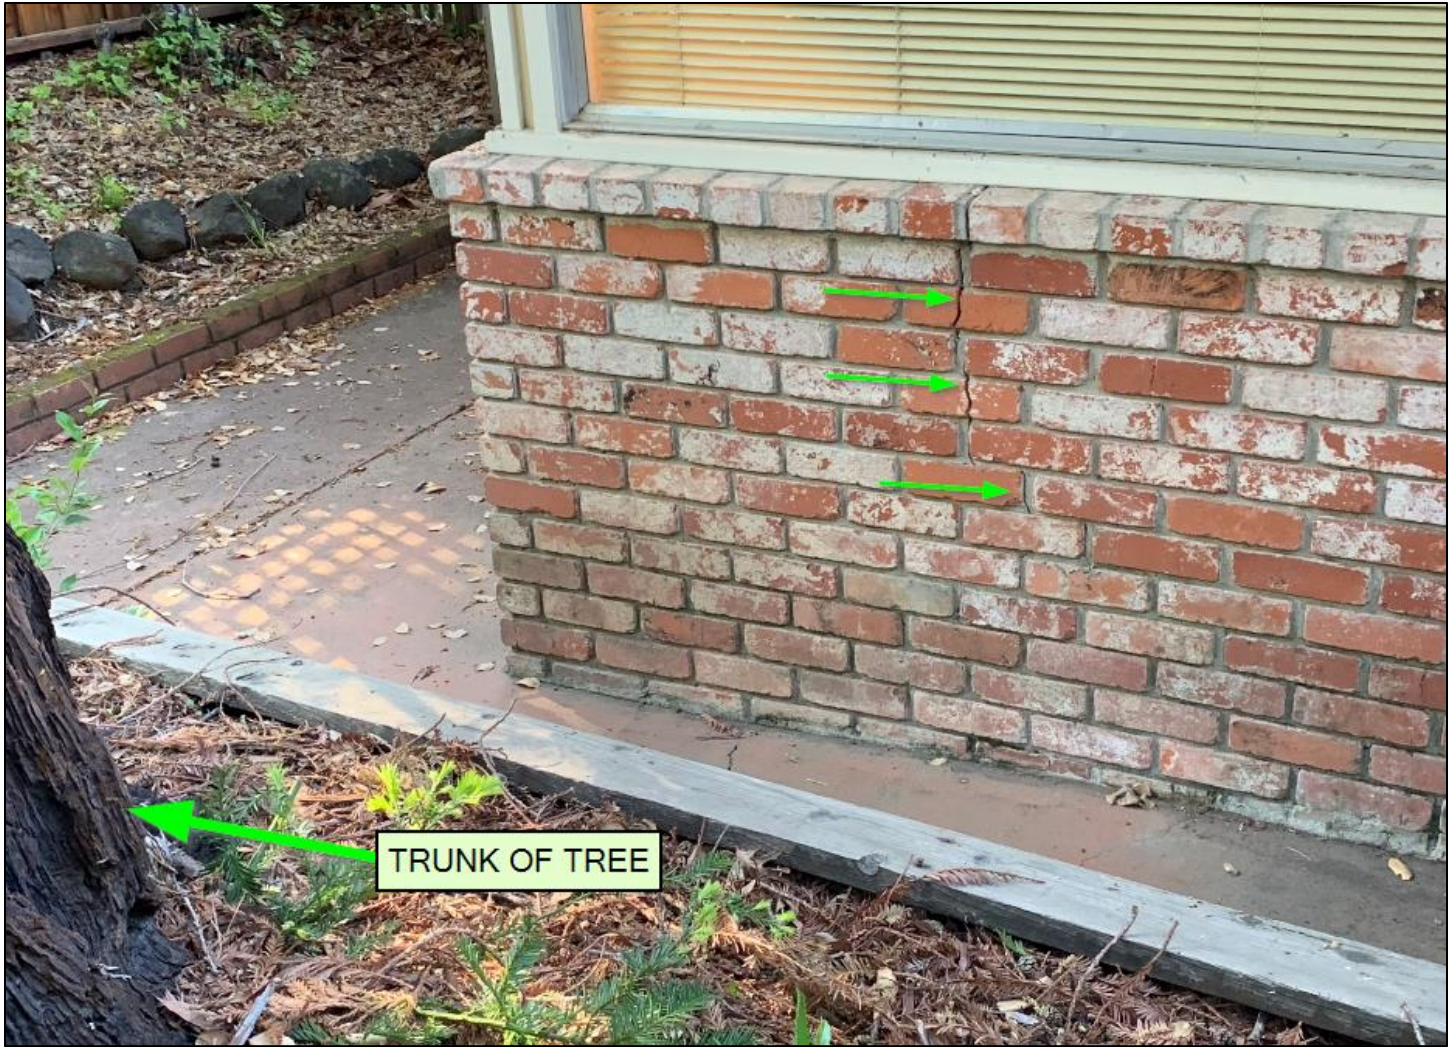
The subject tree has outgrown the site and threatens the reasonable use of the property and integrity of the home. Roots are causing property damage and there are no realistic options for mitigating future root growth (and associated damage) short of whole tree removal. The severity of damage will only increase as the tree continues to grow.

Figure 3. Crack in brick siding

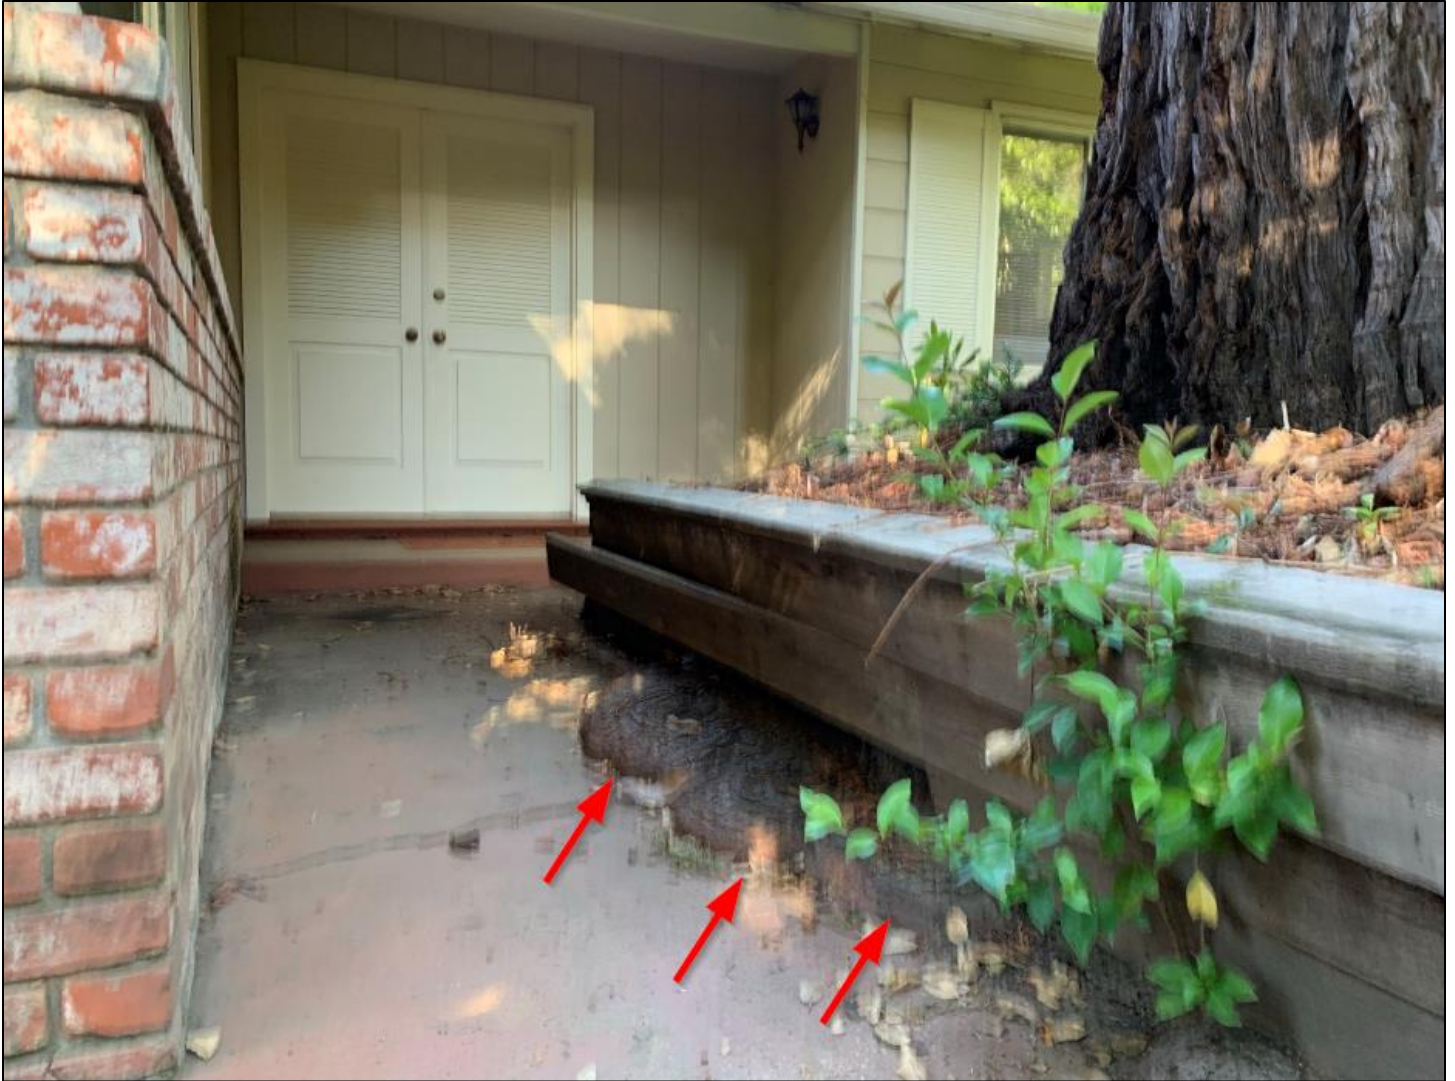
The supportive, or structural roots of the tree are most likely to cause damage to surrounding infrastructure. The distance from the trunk at which these roots can be expected to be found is variable but for the subject tree the structural root zone is a minimum of 15 feet from the trunk. The Hilken home is well within this zone. Growth from the roots and trunk has overflowed onto the walkway, limiting access, and there is a crack in the walkway and brick siding across from the tree. Cracks in home foundations or siding can develop for many reasons, including substandard construction practices. However, given the proximity of this massive tree to the risk of root damage is real, so the Hilken's concerns are warranted.

Figure 4. The shot is out of focus; however, the red arrows indicate root growth within three feet of the home.
