## ARBORIST REPORT

### Pre-Sale Inspection of Two Valley Oaks 52-54 Tamalpais Avenue San Anselmo, California (APN: 007-211-30)

August 15, 2019

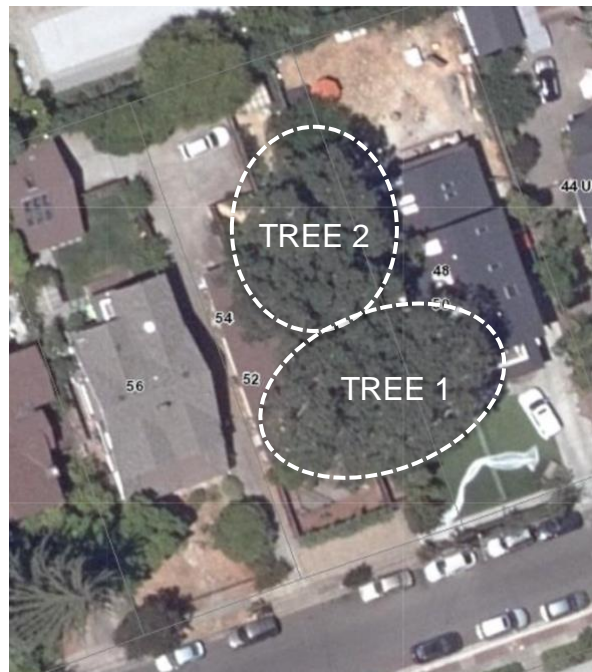
The duplex at 52-54 Tamalpais Avenue in San Anselmo was built in 1952 on a level, 0.17-acre parcel. This property has mature landscaping that is seasonally shaded by the two subject deciduous oaks (circled in white, right).
